**2023 Alaska Breakup:**  
**Breakup with a spotlight on remote sensing tools**

**NWS Alaska Region Briefing**  
**Alaska Pacific River Forecast Center**

# 2023 Spring Breakup in Review

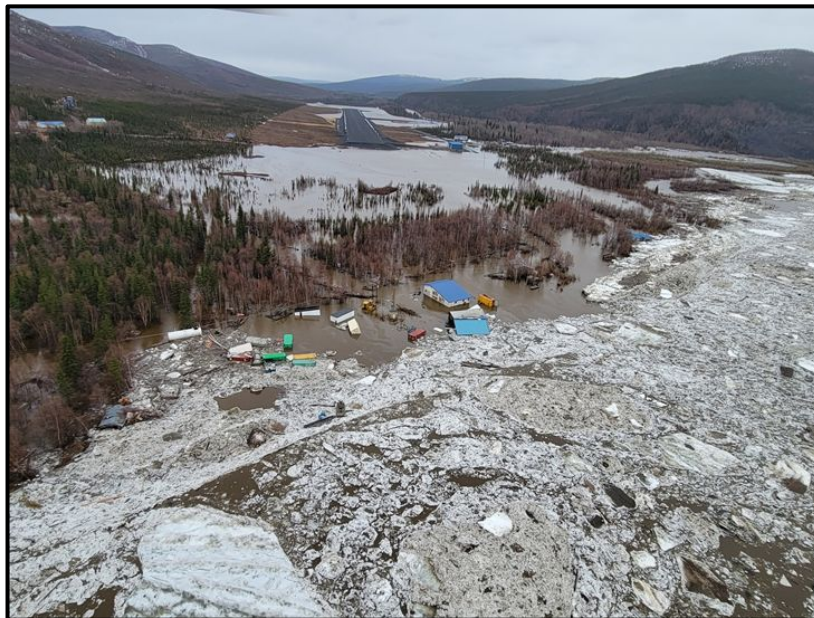
*Aerial view of flooding of Crooked Creek on the Kuskokwim River on May 14th.*

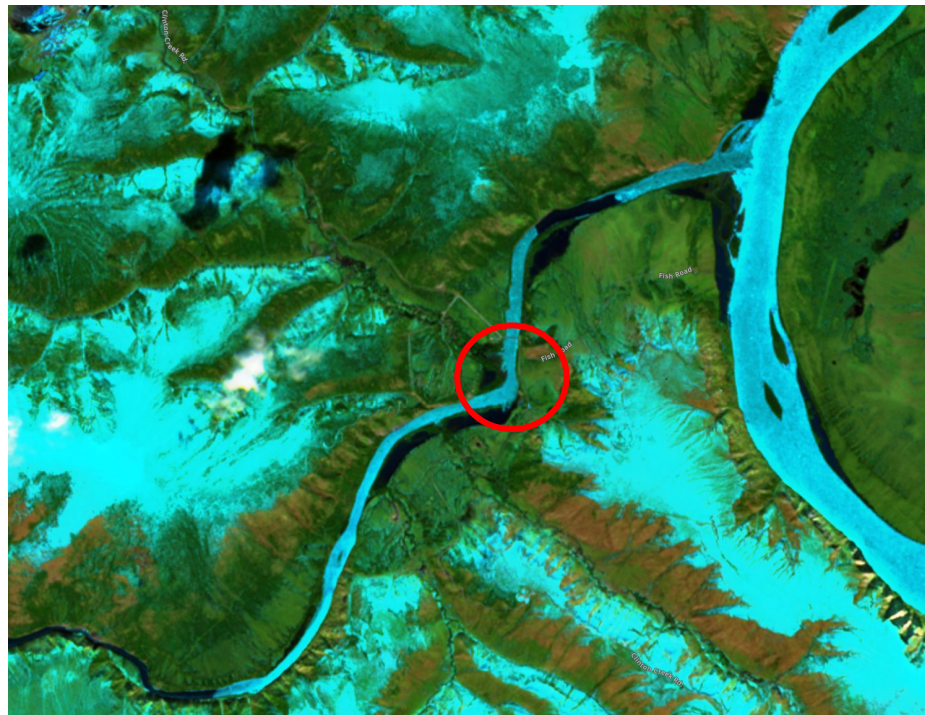
Two ice jams form on the Forty Mile River, flooding Clinton Creek Road and Taylor Highway

*Sentinel-2 L2A SWIR image showing ice jam on forty mile at its confluence with the Yukon.*

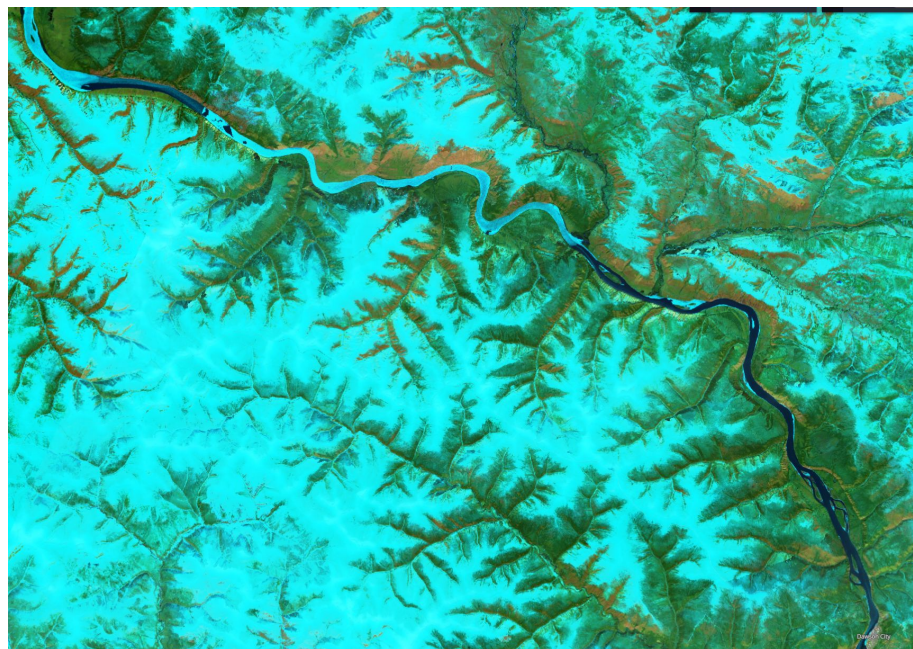
*Sentinel-2 L2A SWIR image showing ice run below Dawson. This bit of ice is around 20 miles long.*

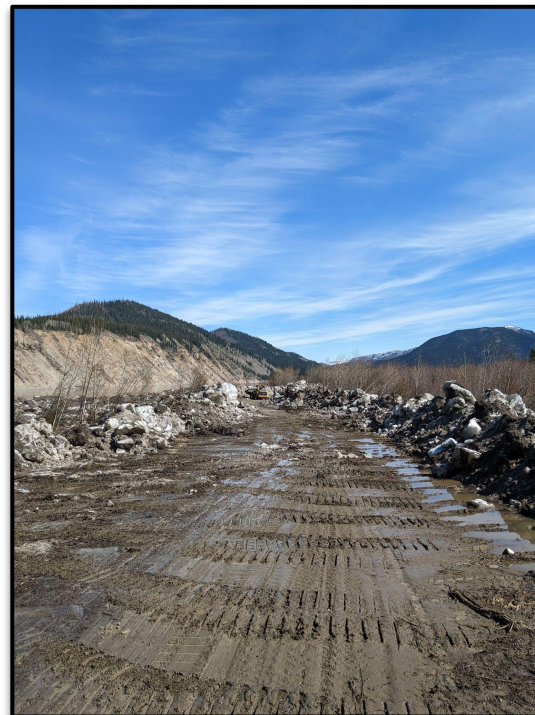
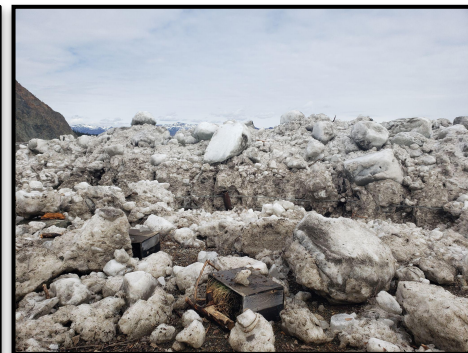
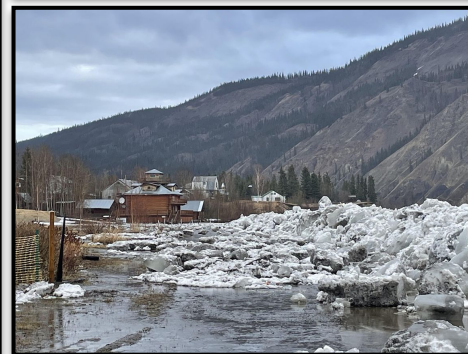
Ice jam forms downstream, moderate flooding with damage to seawall, flooding roads, and damage to several structures.

*Clockwise from top right: seawall damage on Front St on May 13th; aerial view of Mission Rd between Eagle and Eagle Village on May 13th; DOT crews removing ice and repairing washouts along Mission Rd on May 18th.*

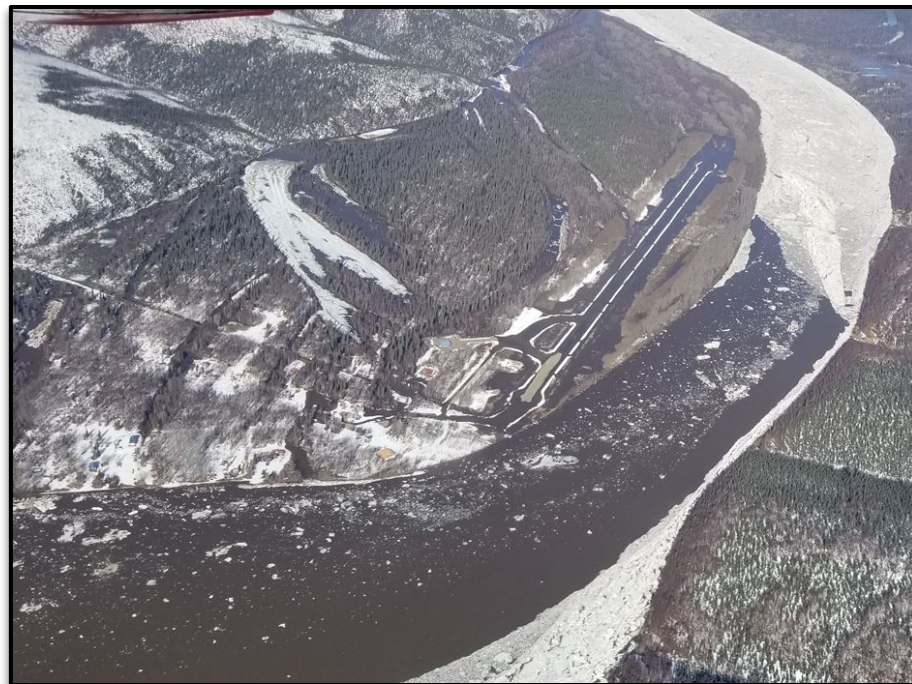
Water levels rise rapidly, structures inundated, and damage to runway.

*Aerial view of Red Devil showing extensive flooding to the runway on May 13th.*

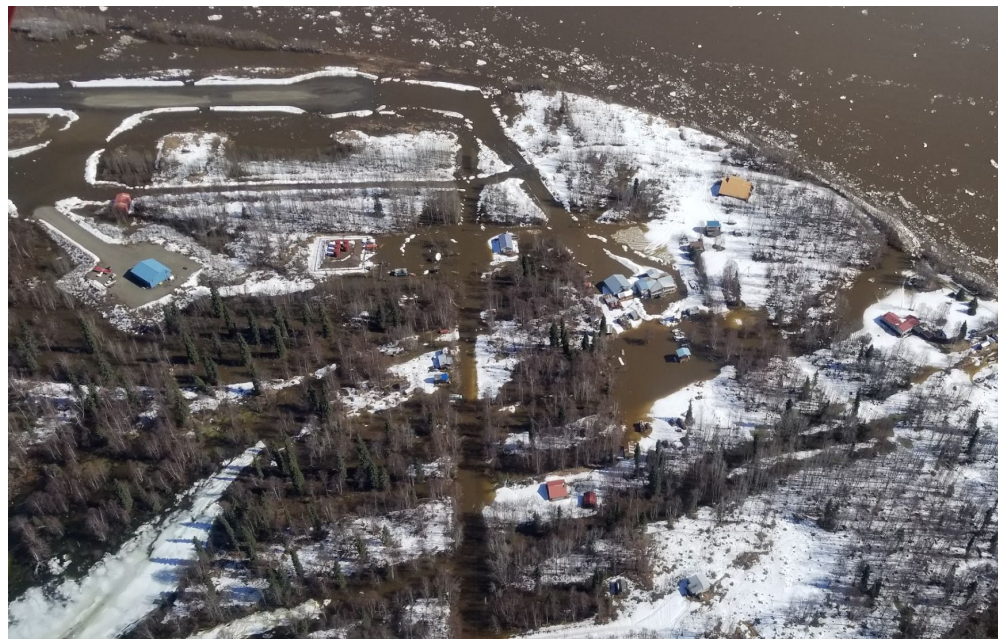
*Aerial view of Red Devil showing extensive flooding to the runway on May 13th.*

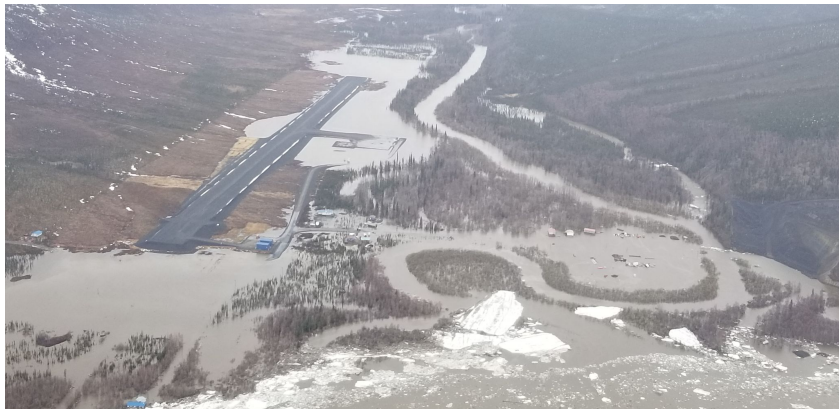
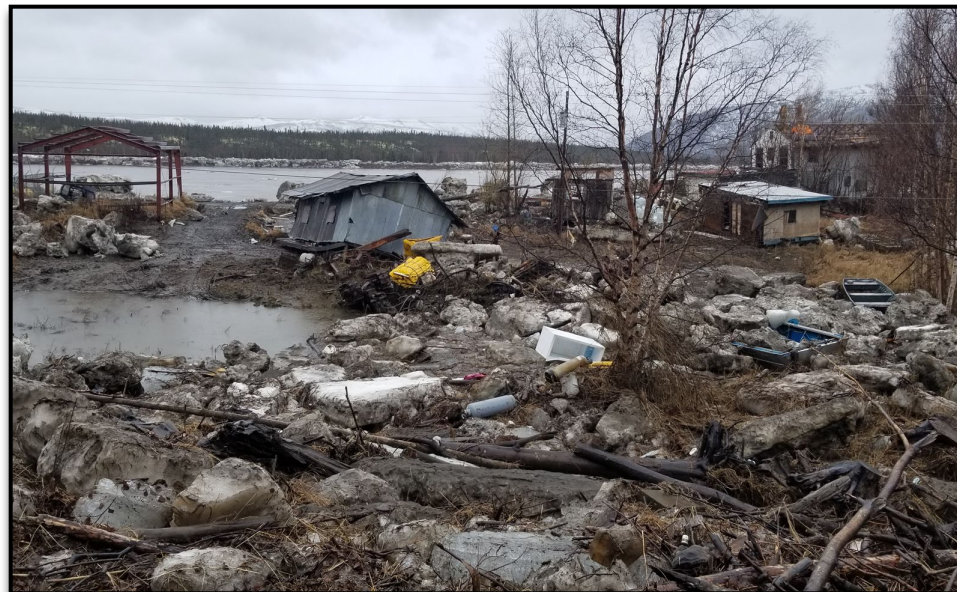
Water levels rose 16ft, exceeding the 2011 record. Residents airlifted by National Guard. Structures destroyed by ice and flood waters.

*Extensive damage to structures, with stranded ice and floodwaters, and debris in Crooked Creek - May 15th.*

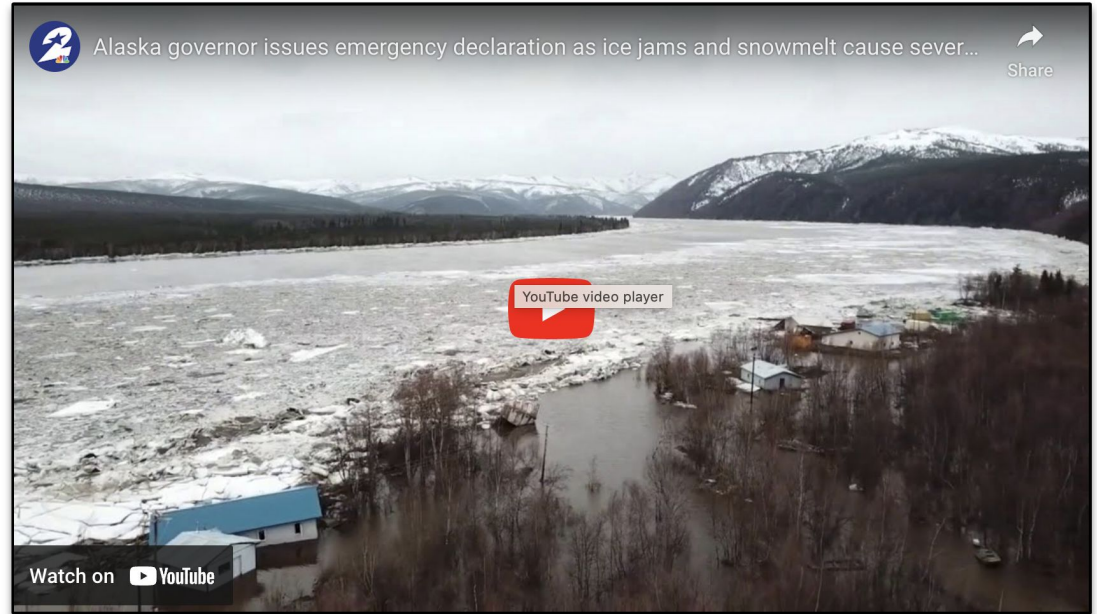
NWS drone video of major flooding in Crooked Creek, AK May 14, 2023

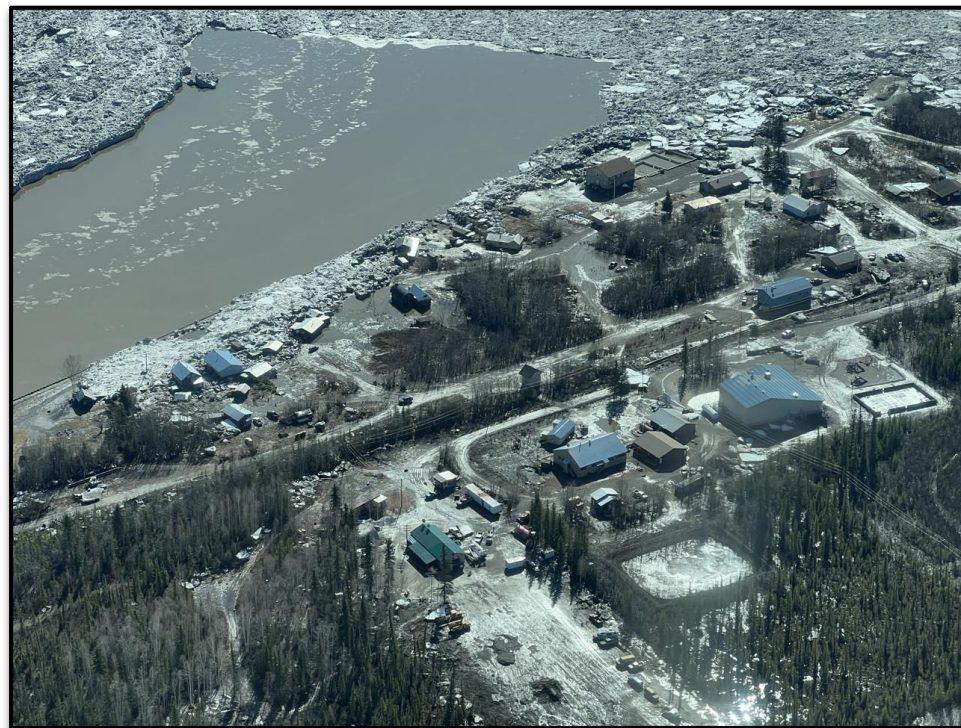
Extensive damage, flood waters exceed flood of record (1945). Most structures in town flooded or damaged by large chunks of ice, and airport apron and taxiway flooded.

*Stranded ice and floodwaters in Circle with residential structures damaged shifted off foundations - May 14th.*

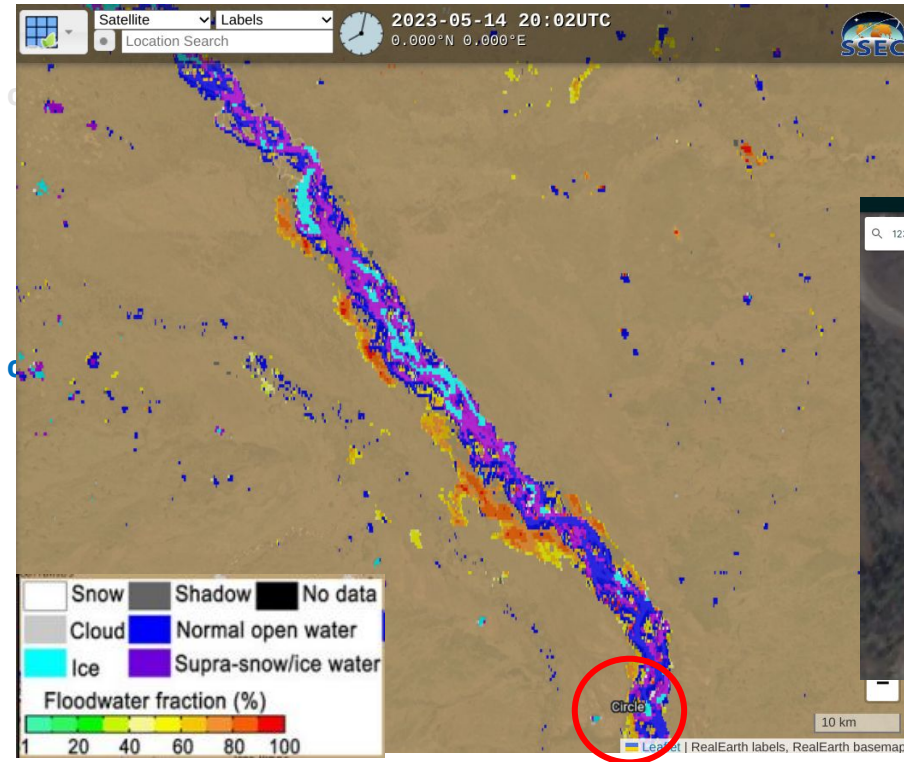
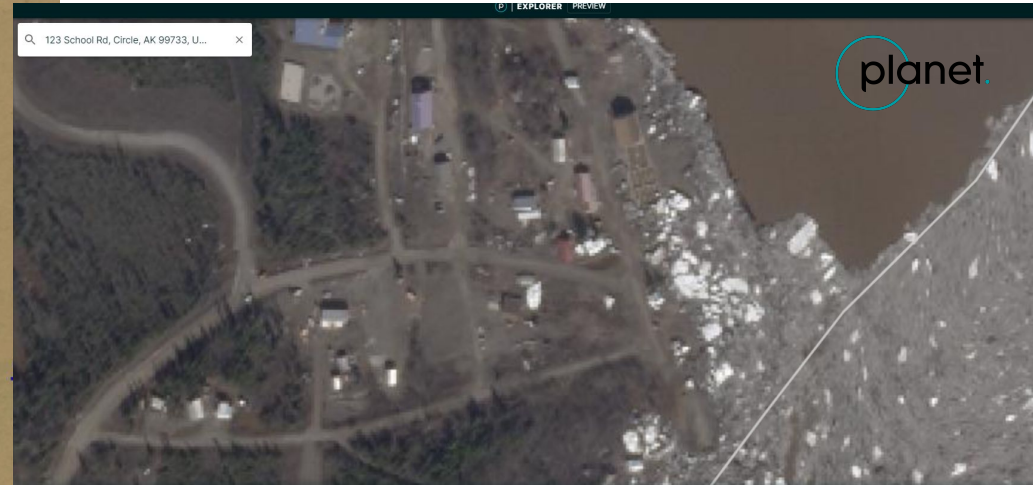
*Stranded ice in Circle from Planet.com imagery - May 14th.*

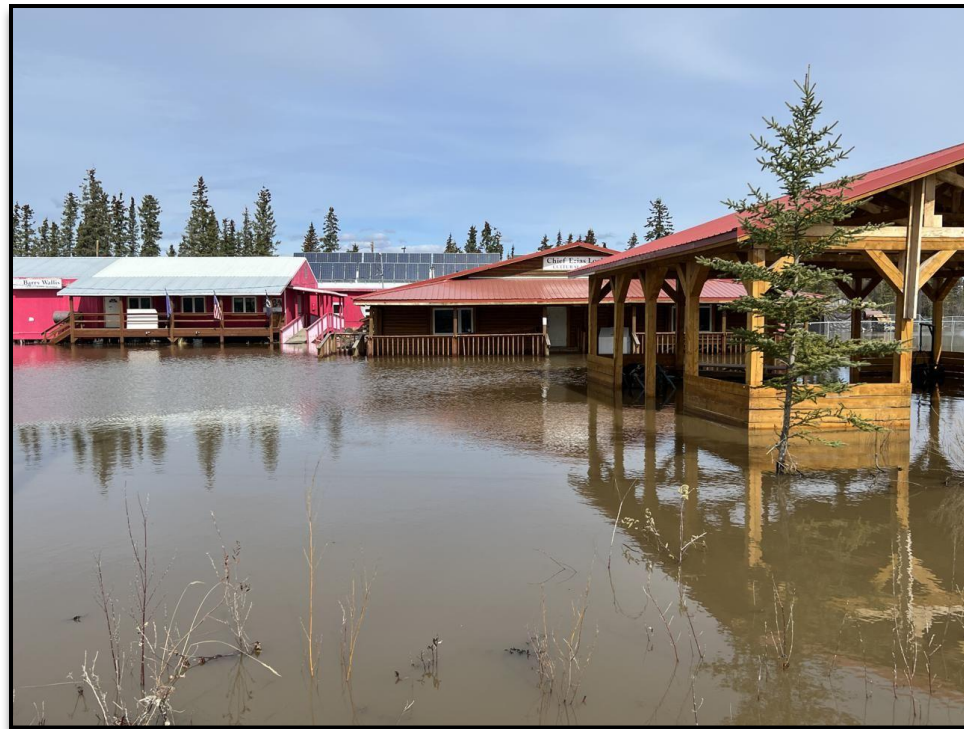
Upper Yukon River at Ft. Yukon breakups up and moderate flooding occurs. Several roads, homes, and structures, including the Tribal Hall, inundated with water.

*Flooding along Base Road, Fort Yukon - May 15th.*

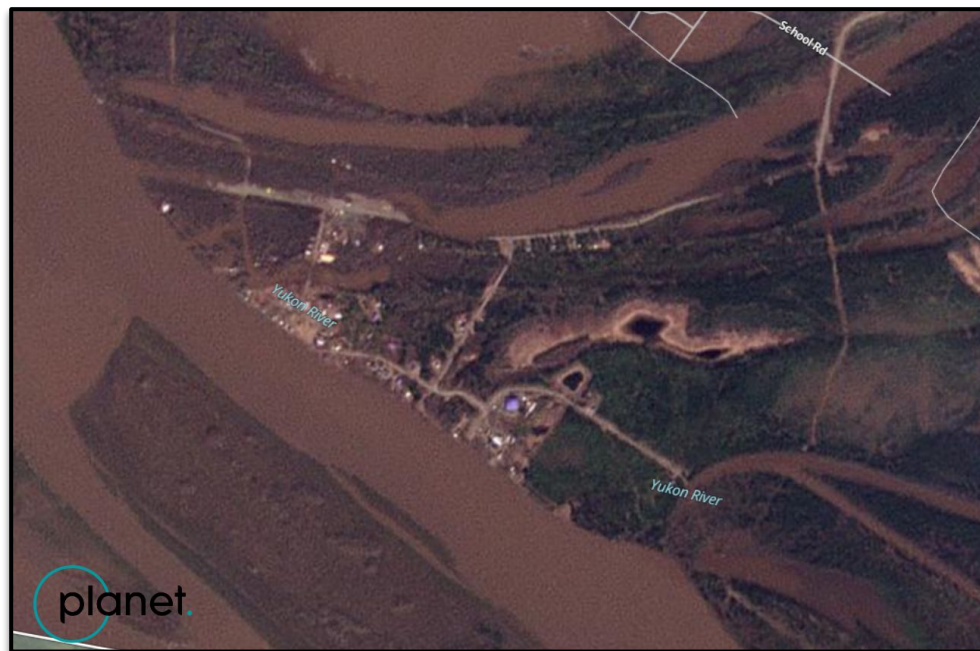
Breakup front on the Yukon River moves past Stevens Village; minor flooding to roads and barge landing.

*Satellite imagery of Stevens Village along the Yukon River showing flooding to low lying areas and roads - May 22nd.*

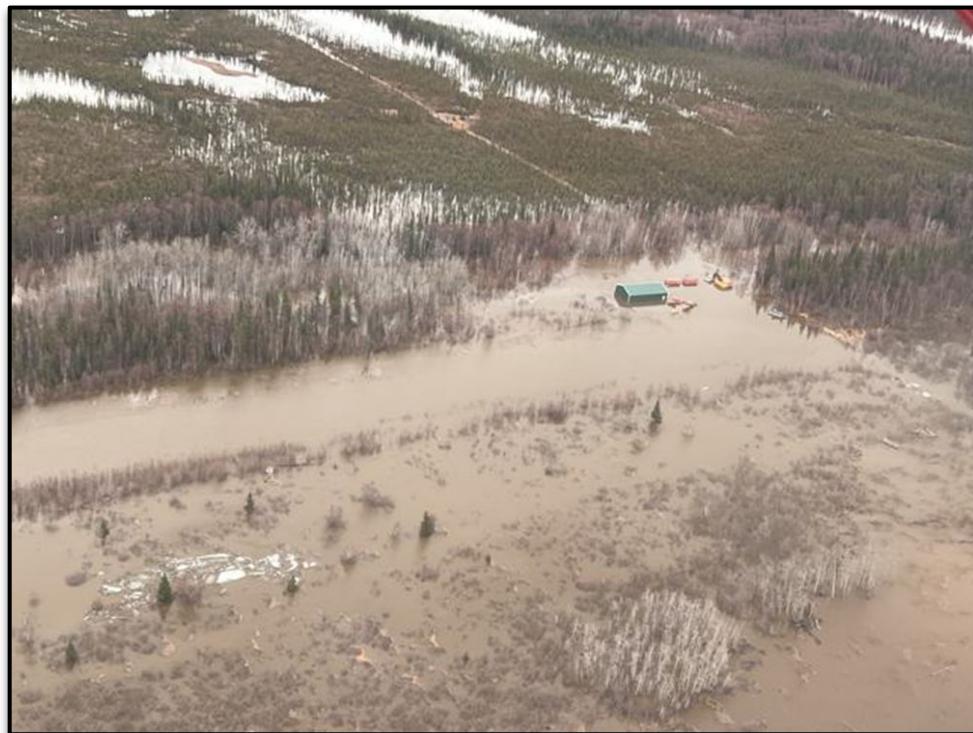
Breakup front on the Kuskokwim River moves down river with minor flooding to homes and runway.

*Aerial image of the runway at Napaimute - May 22nd.*

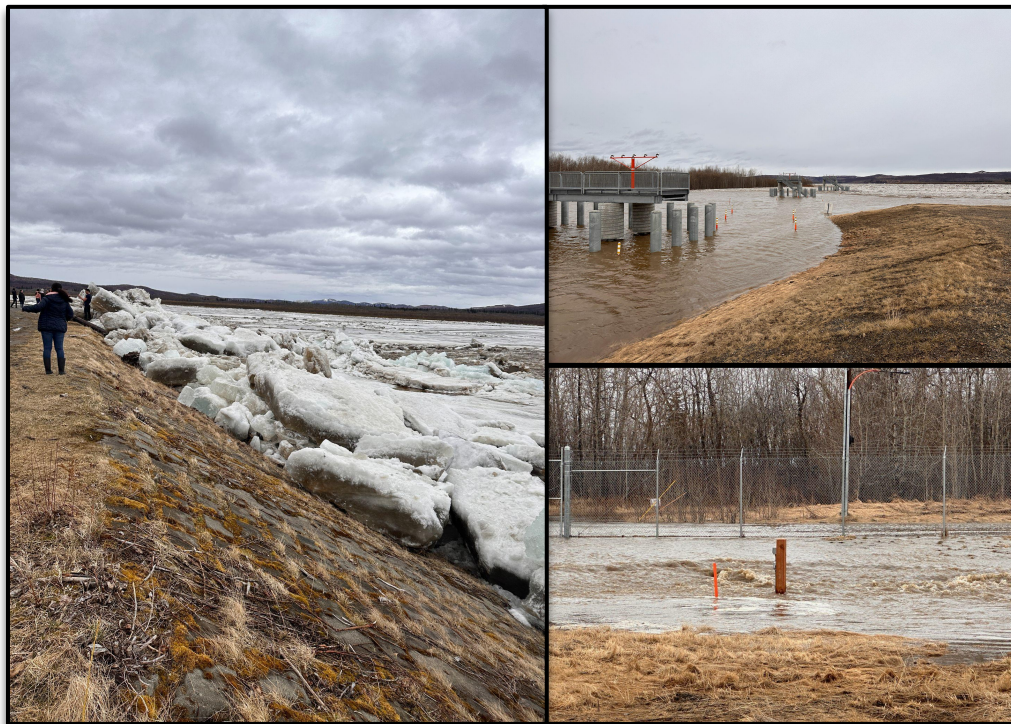
Breakup front on the Kuskokwim moves past Aniak, with minor flooding at the airport.

*Clockwise from top right: Runway lights surrounded by water. Lower right-road covered by flood water. Left-Ice shoved up against Aniak dike.*

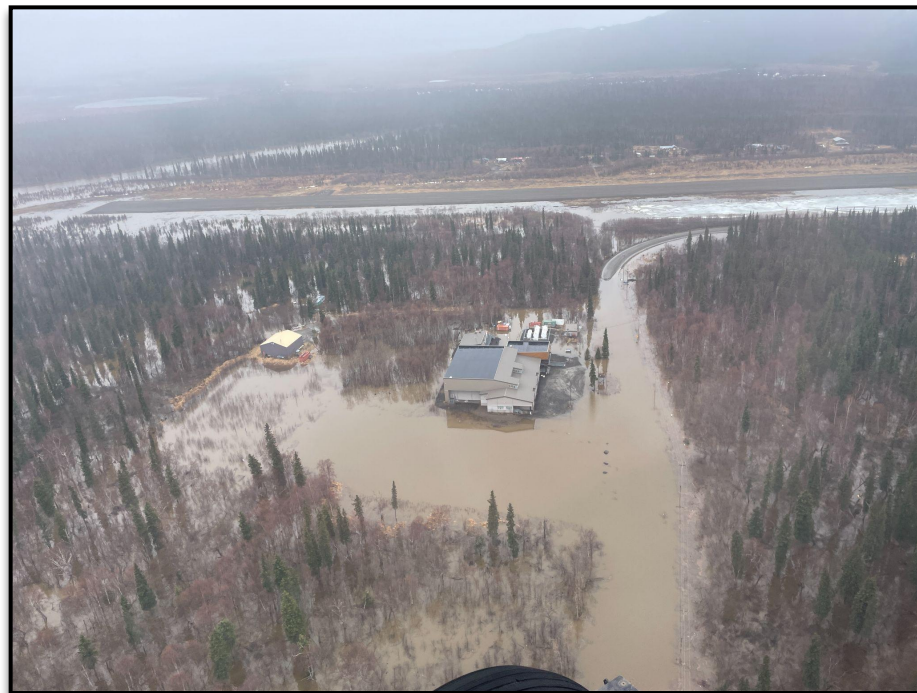
ice jam on the Kuskokwim river raises water levels and causes minor flooding near of roads and water under homes.

*Aerial view of flooding around airport runway, with water surrounding homes and structures and flooding of the roads between Upper and Lower Kalskag - May 17th.*

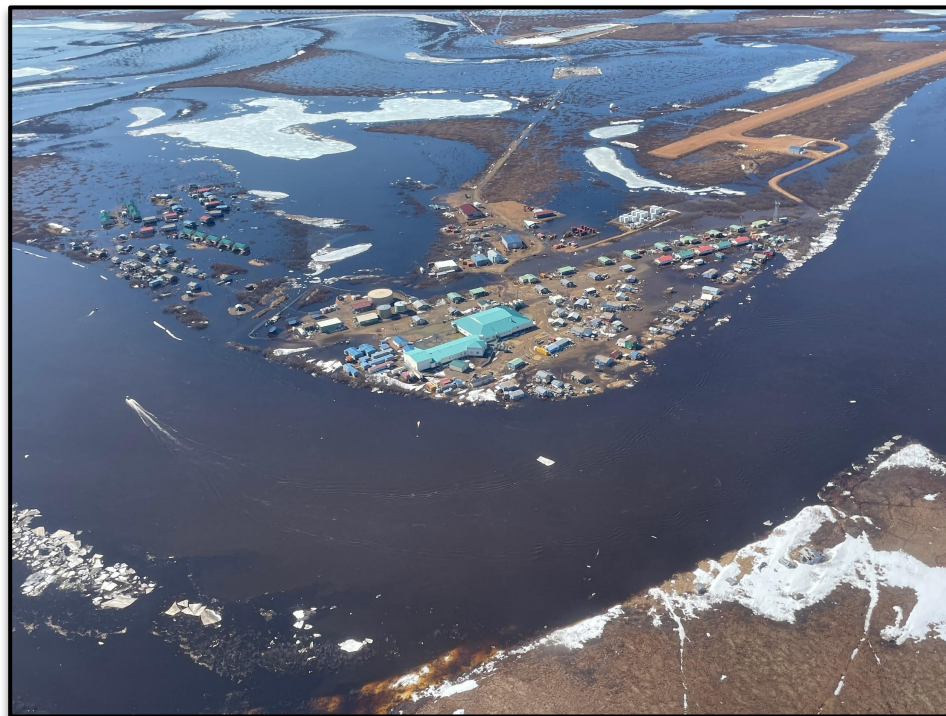
Multiple ice jams on the Buckland River causes significant flooding to nearly 80% of community. Roads inundated with water; water under or surrounding homes and structures.

*Aerial imagery from River Watch team over the community of Buckland - May 18th.*

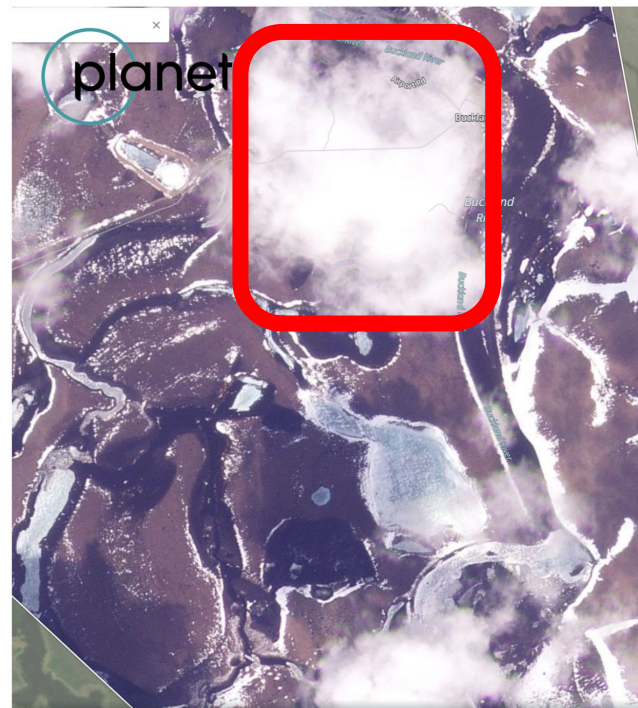
*Ice Jam Upstream of Buckland - May 17th.*

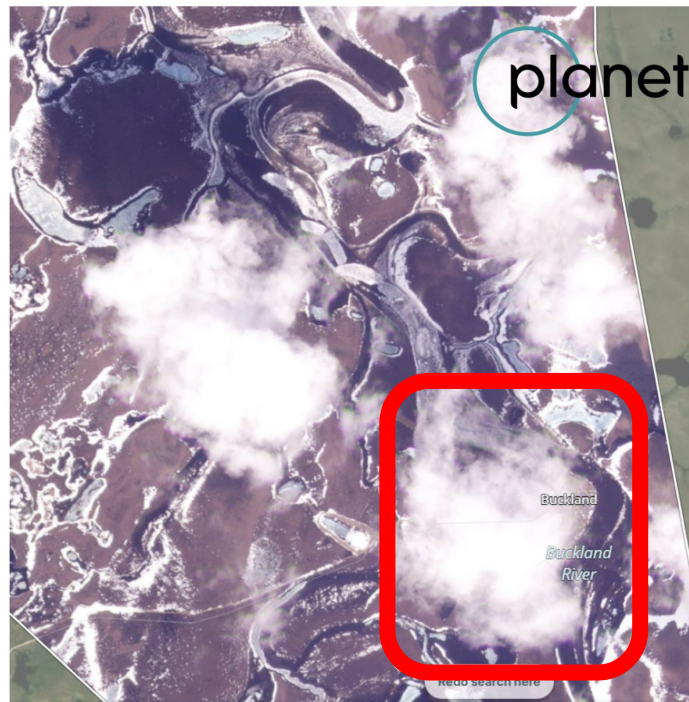
*Ice Jam Downstream of Buckland - May 17th.*

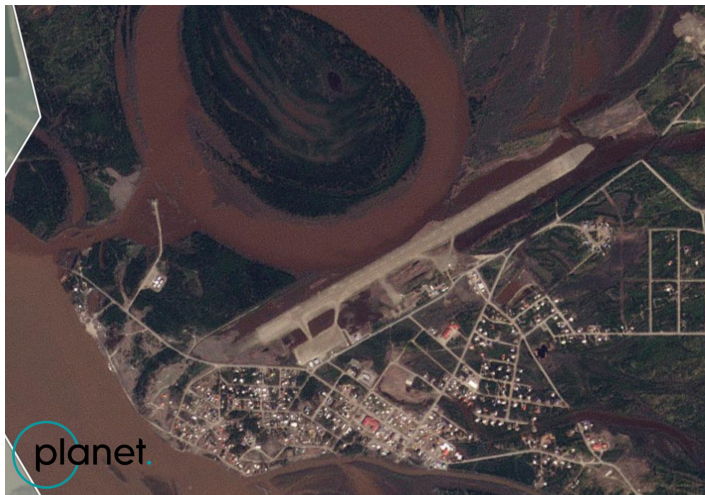
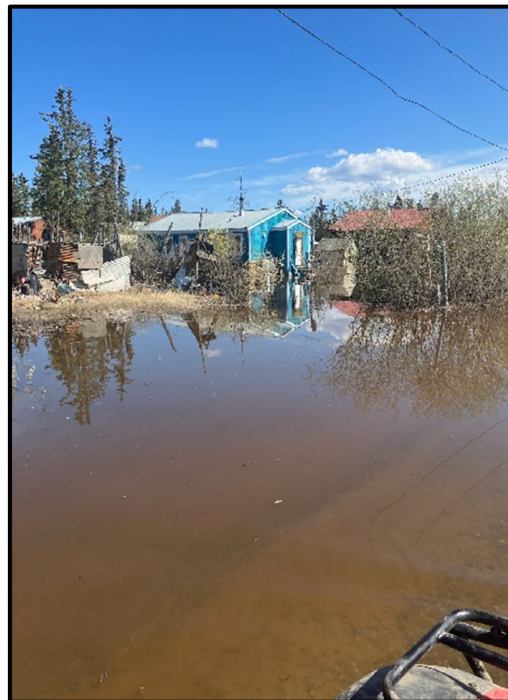
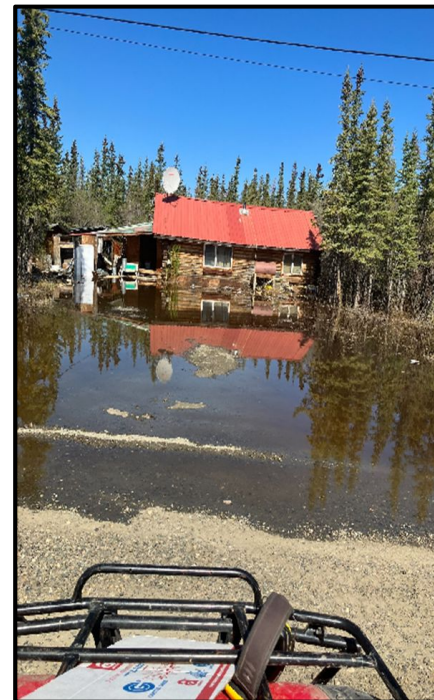
### Snowmelt flooding Ft Yukon

Immediately following breakup flooding, gradual snow melt caused area rivers to swell and flood several homes and roads in the community.

*Flooding in Ft Yukon*

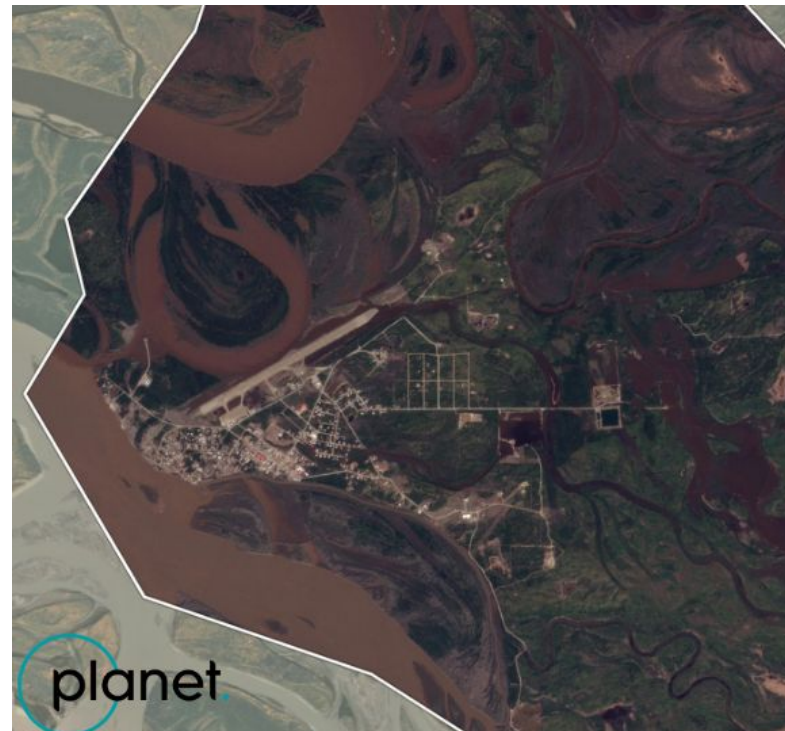
### Snowmelt flooding Ft Yukon

Immediately following breakup flooding, gradual snow melt caused area rivers to swell and flood several homes and roads in the community.

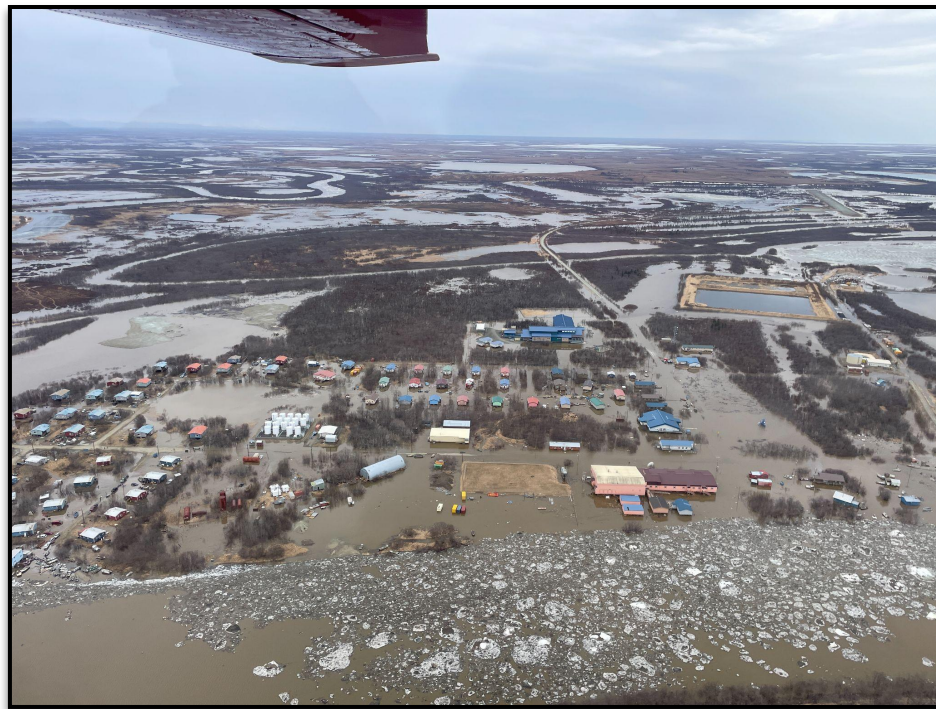
Ice jams release and push large volume of water down Kuskokwim. Water inundated homes, damage to roads and vehicles.

*Flooding in the community of Kwethluk on May 19th.*

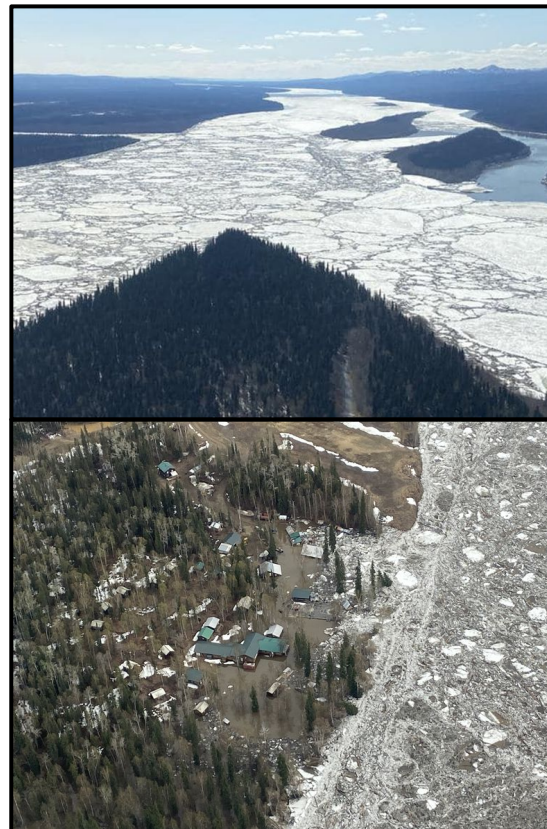
*Significant  
flooding at  
Bible Camp  
near Big Eddy  
on the Yukon  
River - May  
18th.*

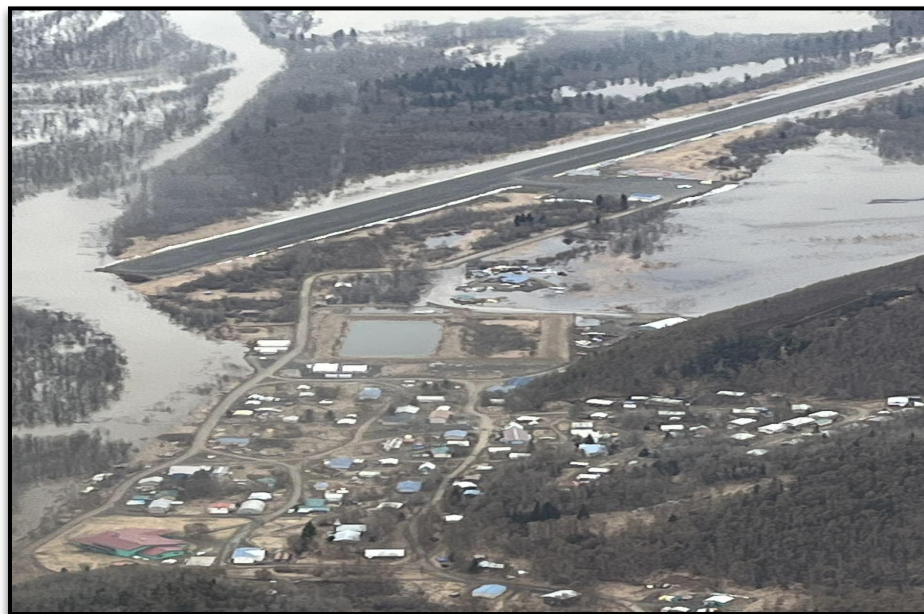
### Minor flooding Holy Cross

The combination of an ice jam up-river and snowmelt lead to flooding, with homes surrounded by water for several days.

*Village of Holy Cross*

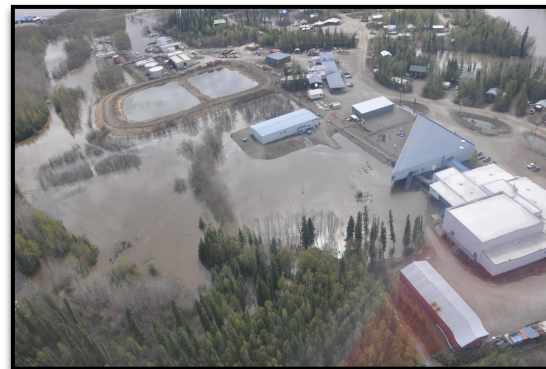
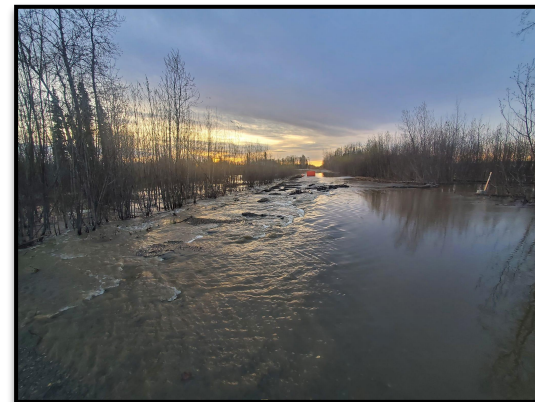
Back water and continued snow melt causes prolonged high water levels on Yukon River, with minor flooding of roads.

*Galena aerial image captured by the U.S. Fish and Wildlife Service on May 24th*

*Road flooding in Galena captured by community member May 23rd*

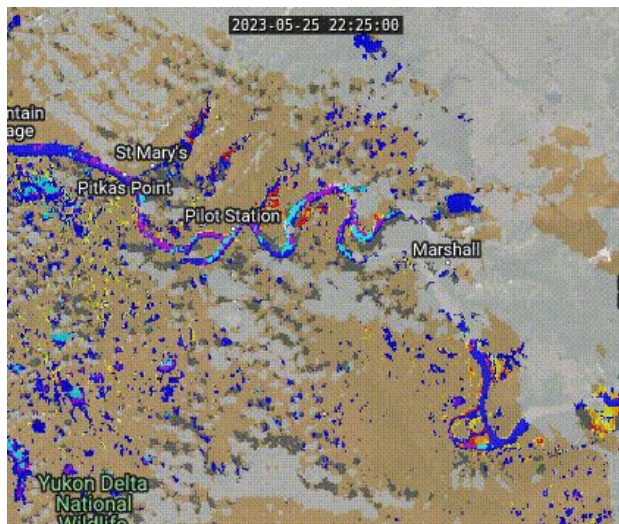
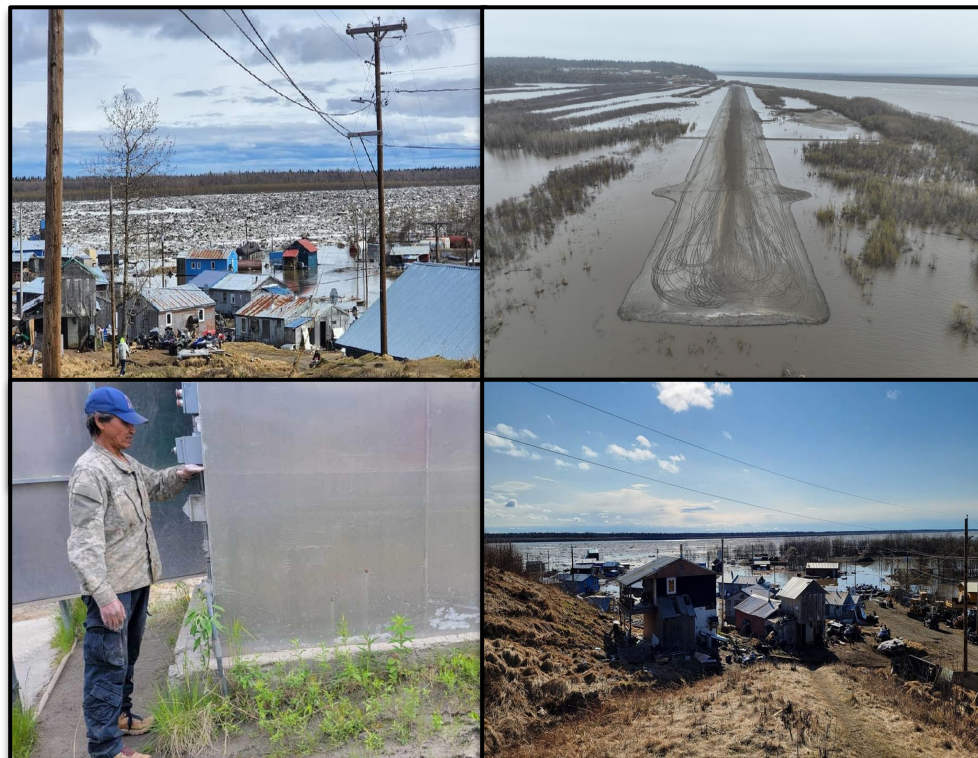
Yukon River ice jam downstream of Russian Mission causes a week long flooding event. Several homes and runaway damaged

*Extent of flooding in Russian Mission, with the airport (top right), and estimated high water mark (lower left), and community (top left/lower right).*

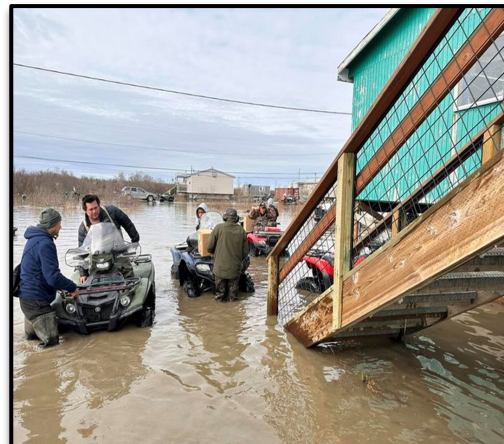
*Flooding observed in Alakanuk May 28th*

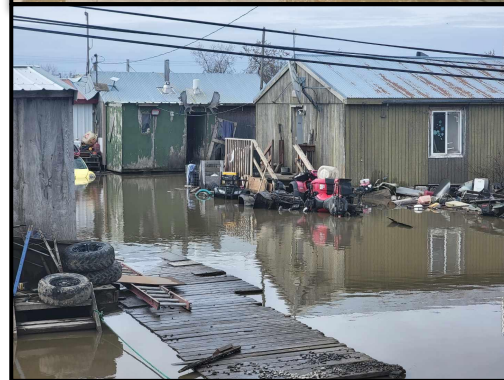
*Flooding observed in Emmonak May 28th*

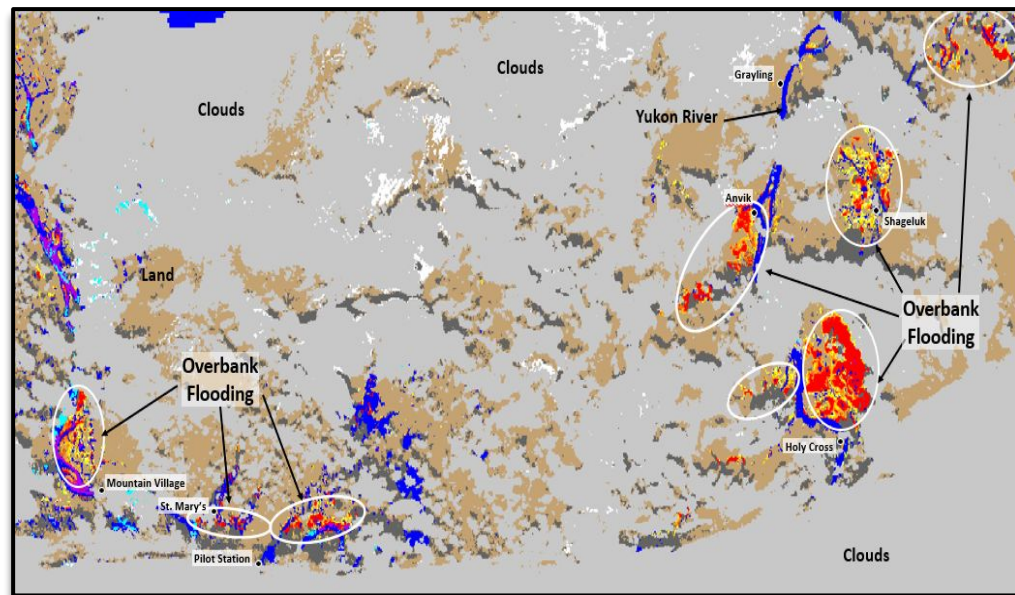
| May 27-29 continued | <b>Backwater and overflow</b><br>Backwater from previous Yukon River ice jams and upstream snowmelt causes widespread overbank flooding of lowlands from Mountain Village to Grayling. |

*VIIRS Imagery showing the extent of out of bank flow and flooding (yellow/orange/red) across the lower Yukon River - May 28th.*

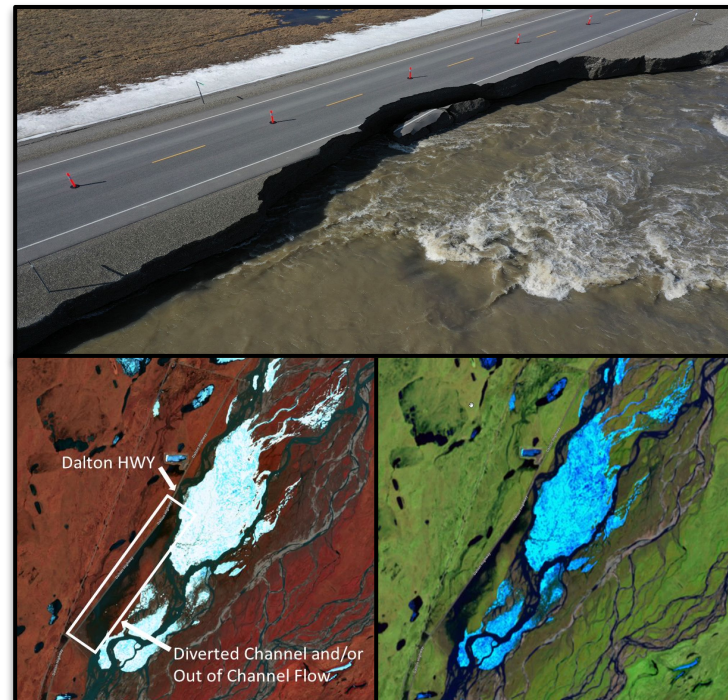
A large area of aufeis remains following breakup on the Sagavanirktok River. The channel diverges and causes significant erosion on Dalton Highway. Enhanced snowmelt keeps water levels high through June.

*Dalton Highway erosion caused by a diverted channel on the Sagavanirktok River on June 7th (top). Sentinel Images highlighting aufeis and diverted channel (bottom left/right).*

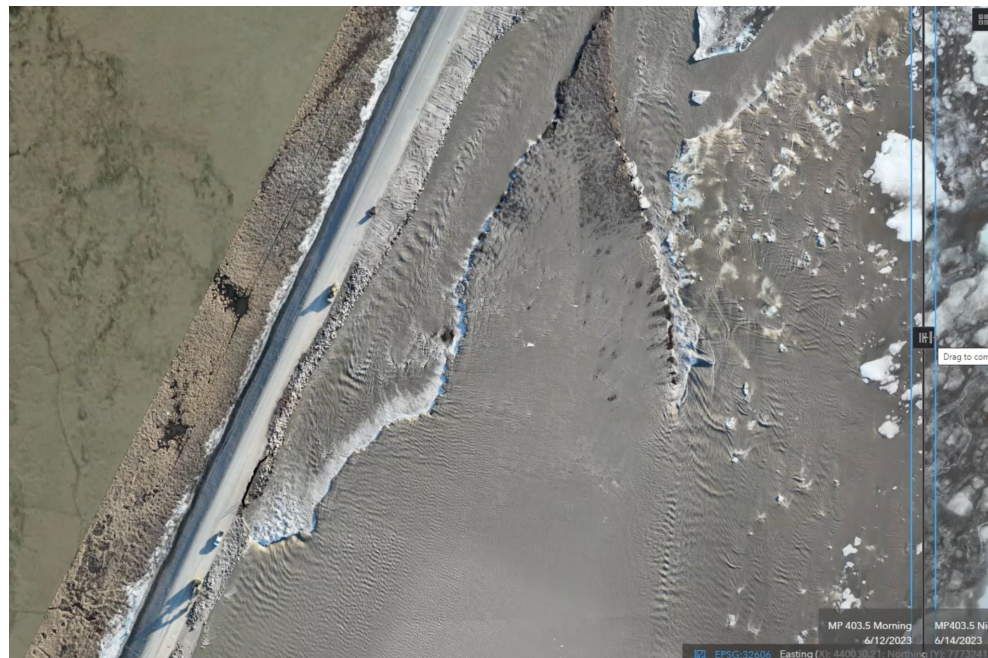
*Dalton Highway erosion June 12th AK DOT Drone*

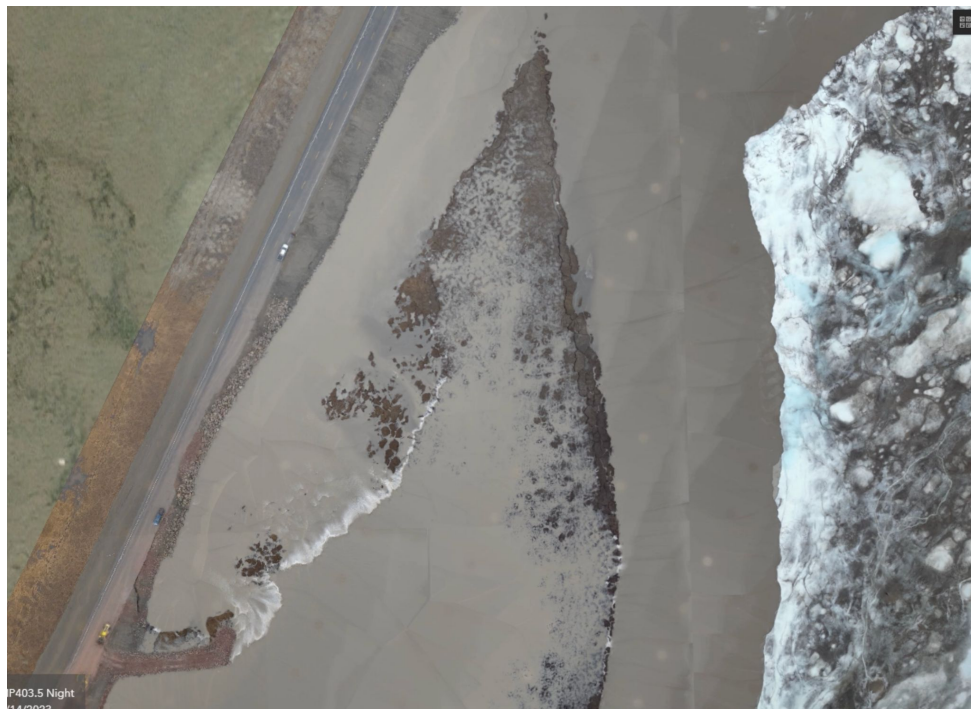
*Dalton Highway erosion June 14th AK DOT Drone*
