**National Centers for  
Environmental Information (NCEI)**

# Flooding and Environmental History in the Upper Tanana Region near Manh Choh

**Virtual Alaska Weather Symposium Talk**

# Tetlin Road Flooding 2017

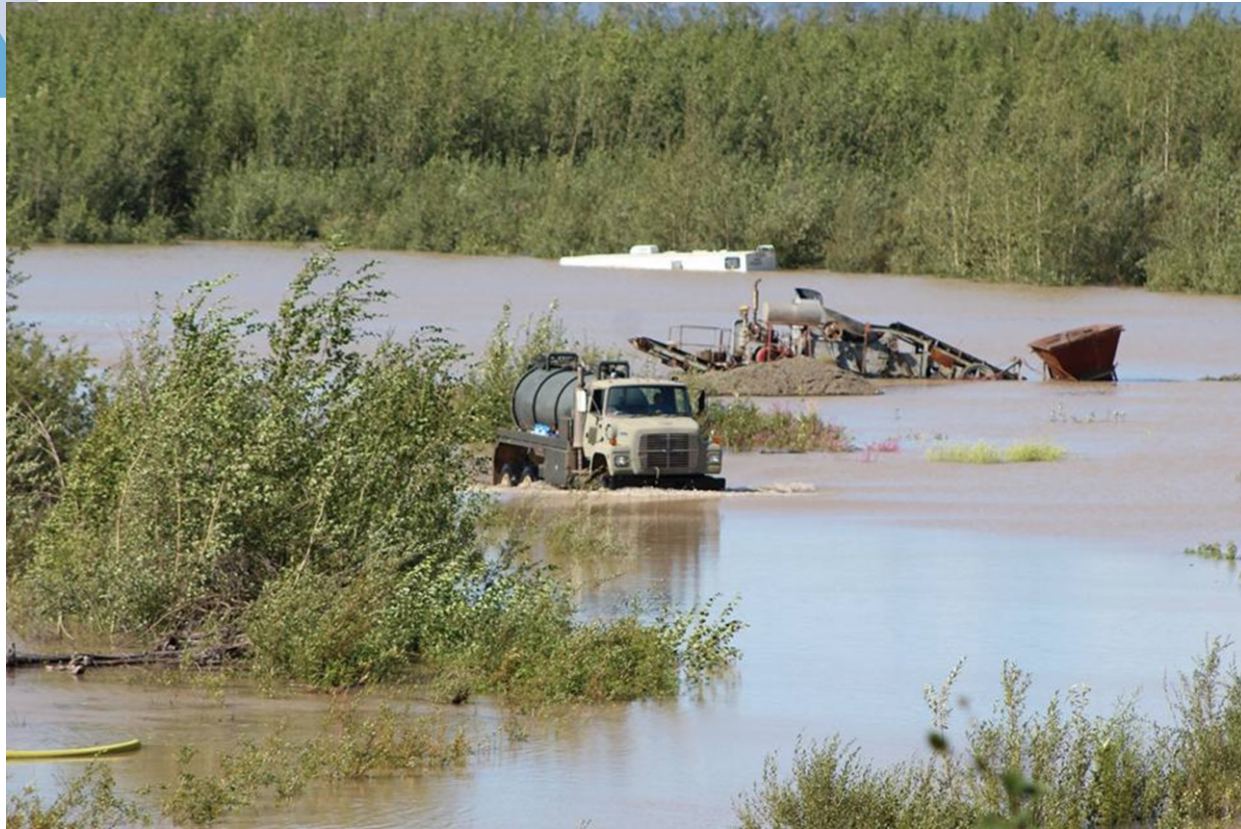
The road between the Village of Tetlin and the Alaska Highway was underwater for 0.75 miles for nearly a month during the summer of 2017.

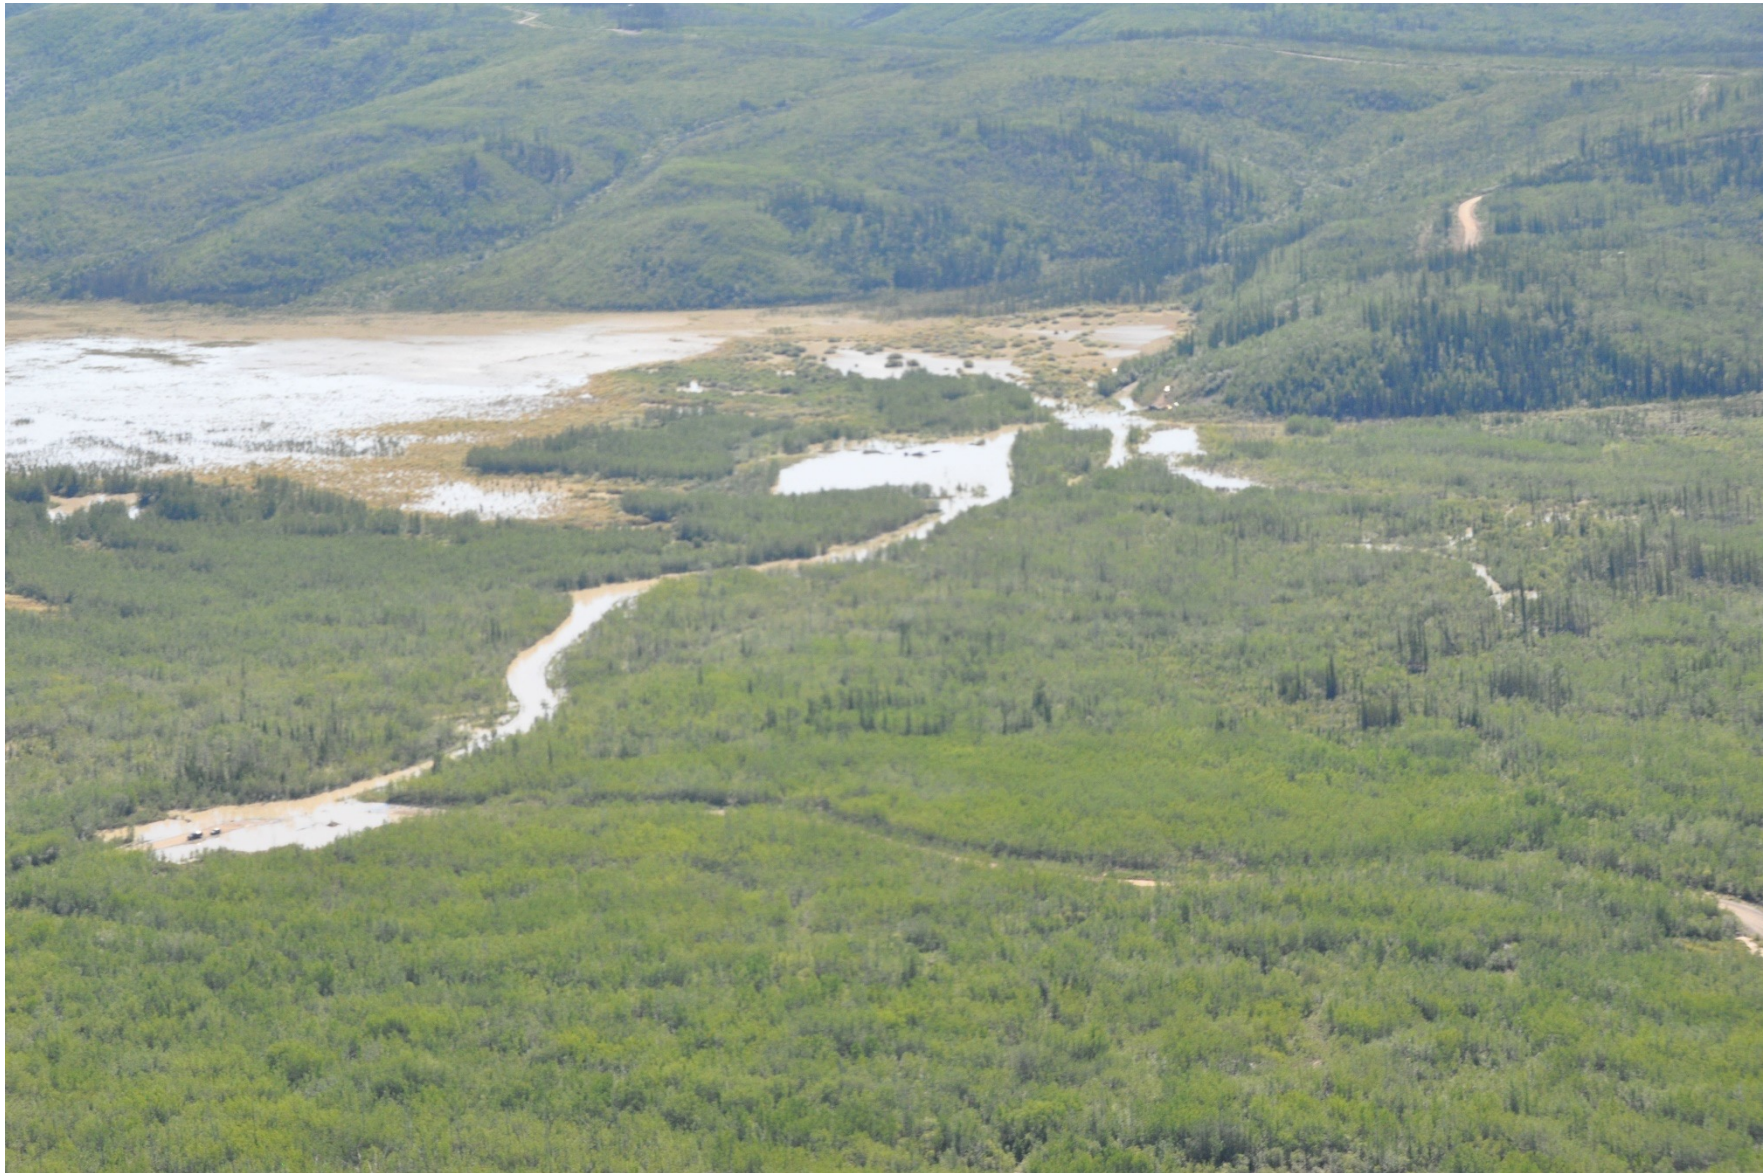
Civil Air Patrol Flight, August 5<sup>th</sup> Looking Southeast at the Flooded Portion of the Road

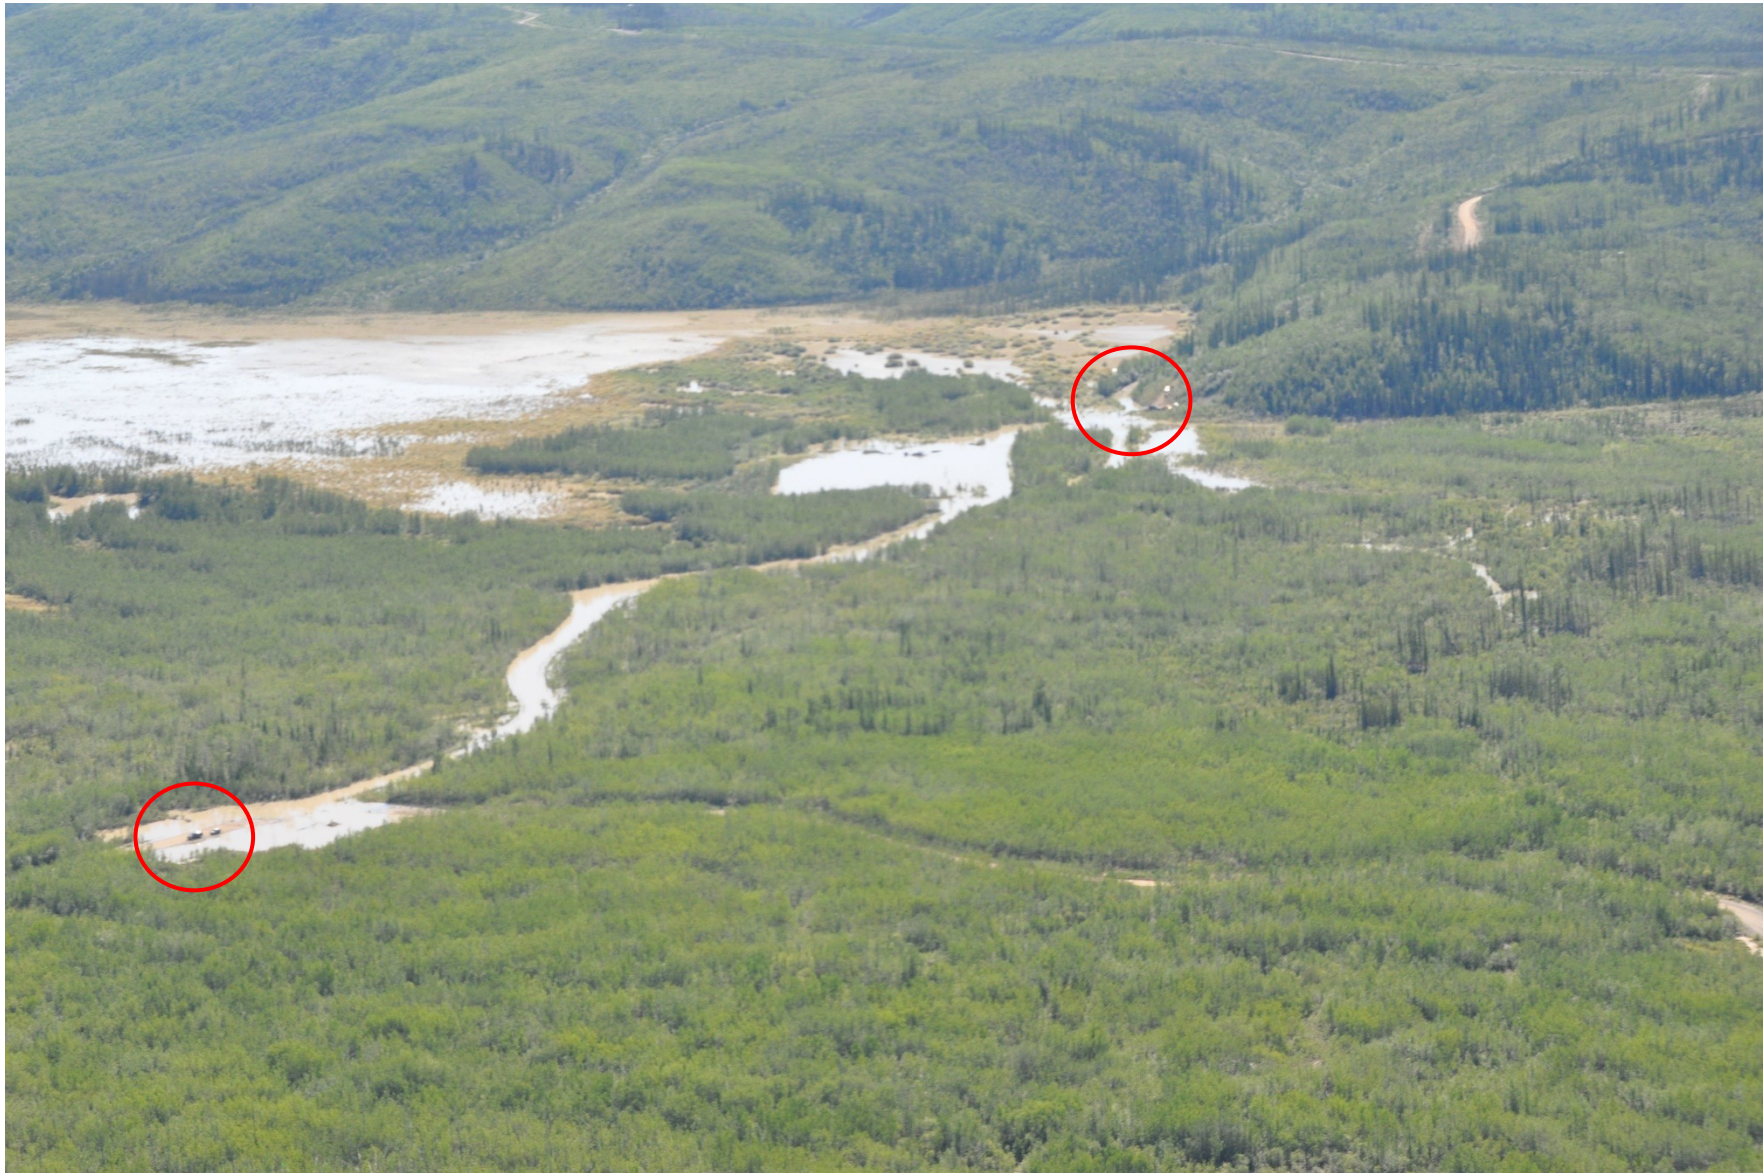
Civil Air Patrol Flight, August 5<sup>th</sup> Looking Southeast at the Flooded Portion of the Road

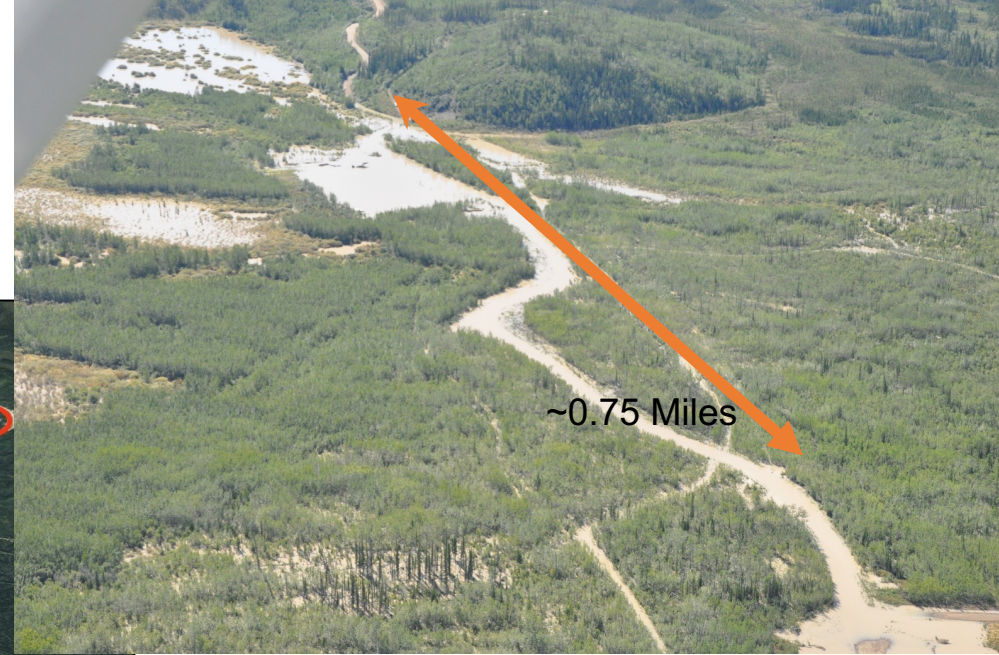
Civil Air Patrol Flight, August 5<sup>th</sup> looking south at the flooded portion of the road

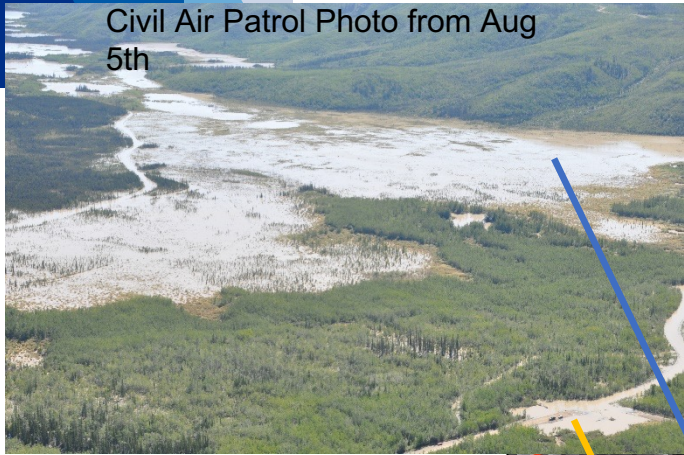
Aug 5<sup>th</sup> SAR Imagery

Satellite imagery between Aug 3<sup>rd</sup> and Aug 5<sup>th</sup> shows similar flooding extents near the Tetlin Road with the area expanding to the North towards the Tanana River.

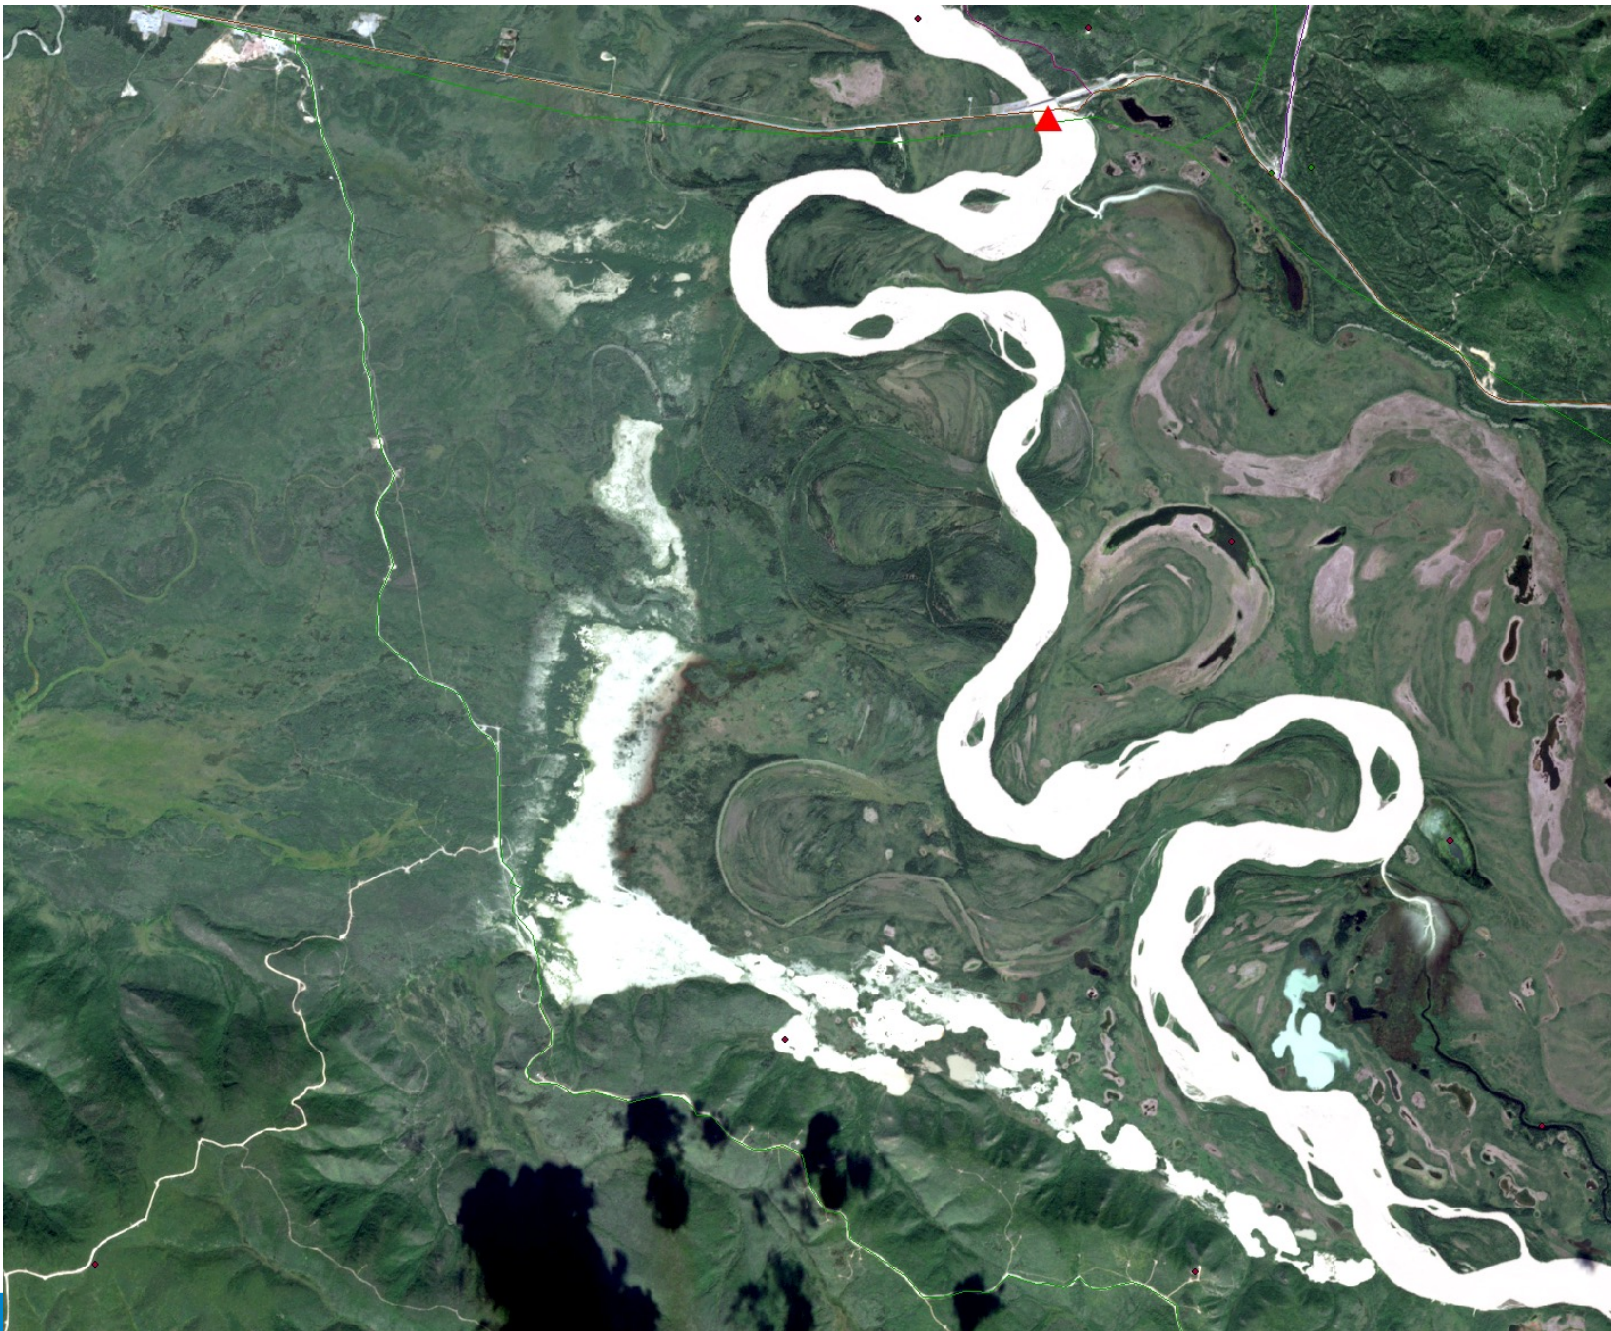
Peak flooding  
on Aug 7, 2017  
SAR imagery,  
Processed by  
Lori Schultz,  
NASA SPoRT

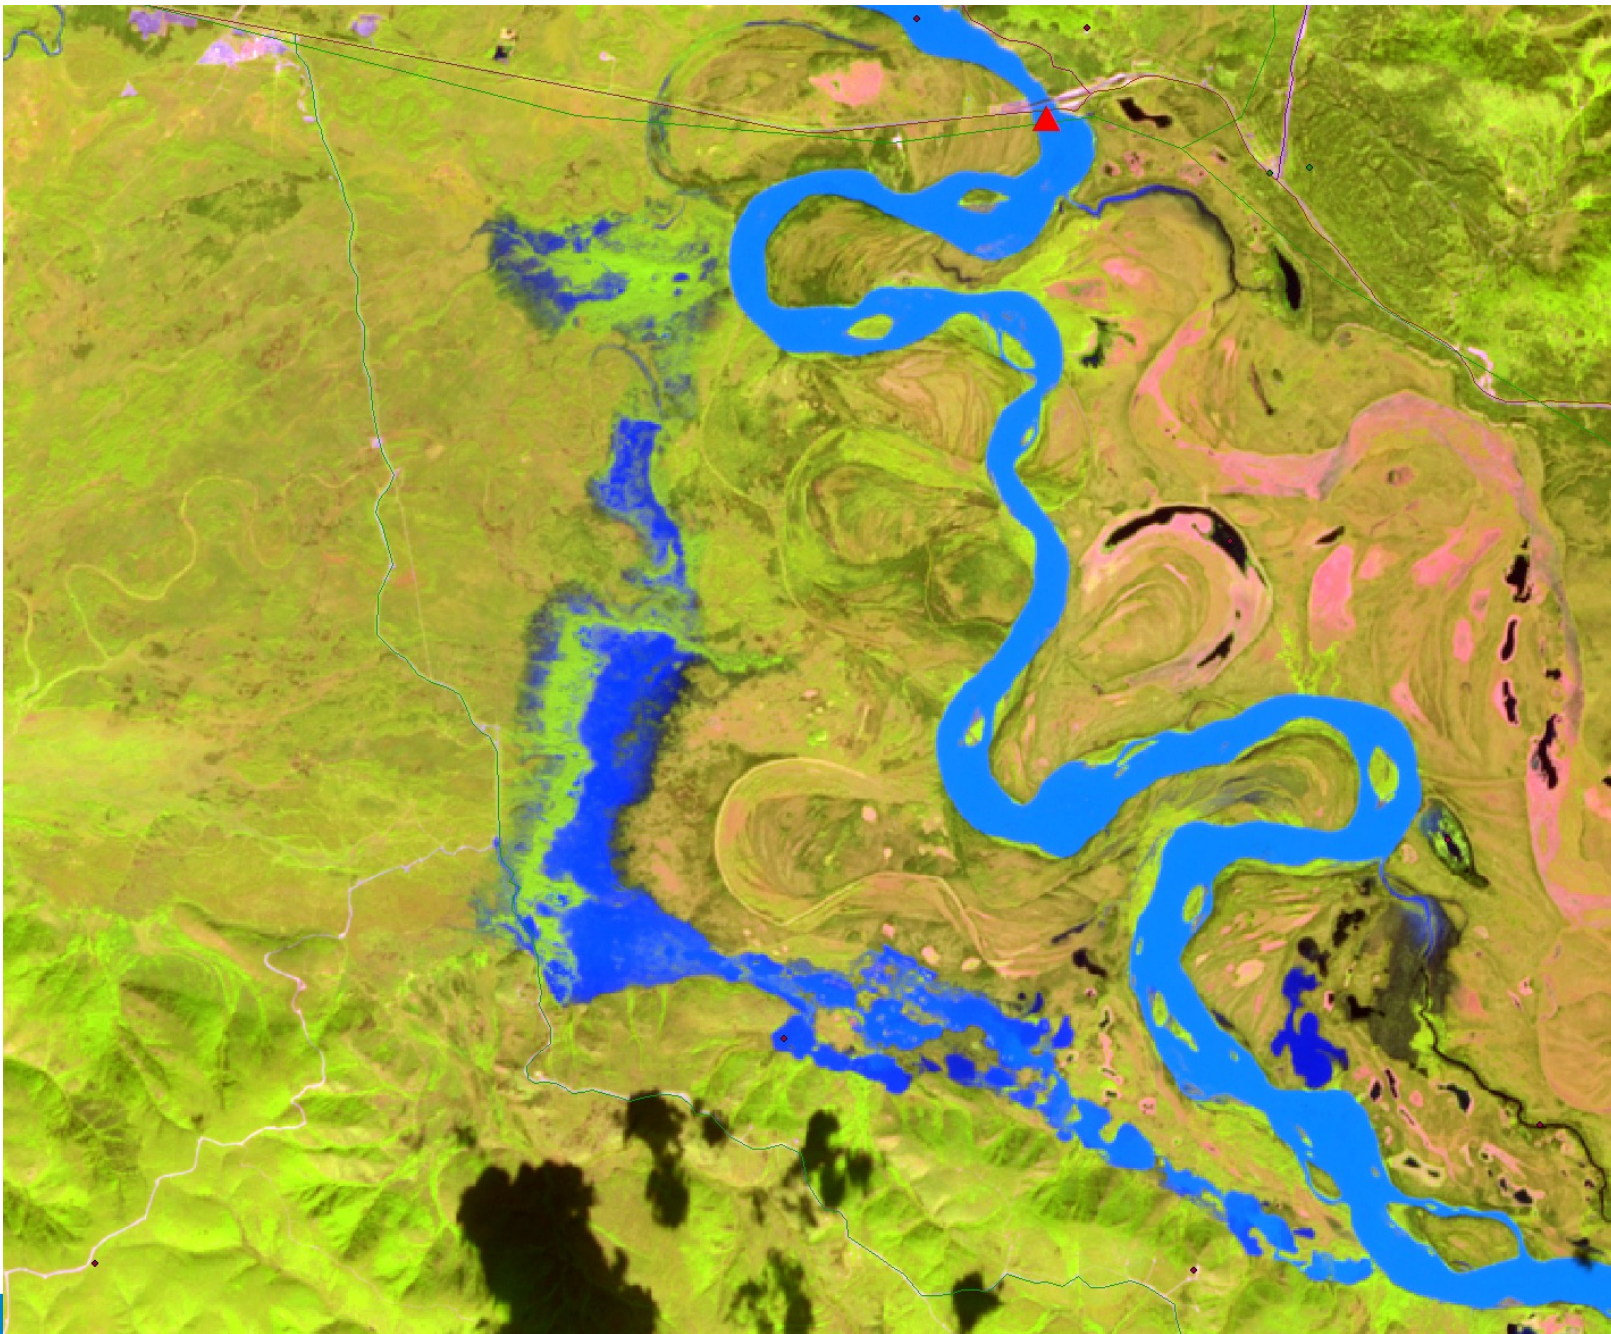
Peak flooding  
on Aug 7, 2017  
SAR imagery,  
Processed by  
Lori Schultz,  
NASA SPoRT

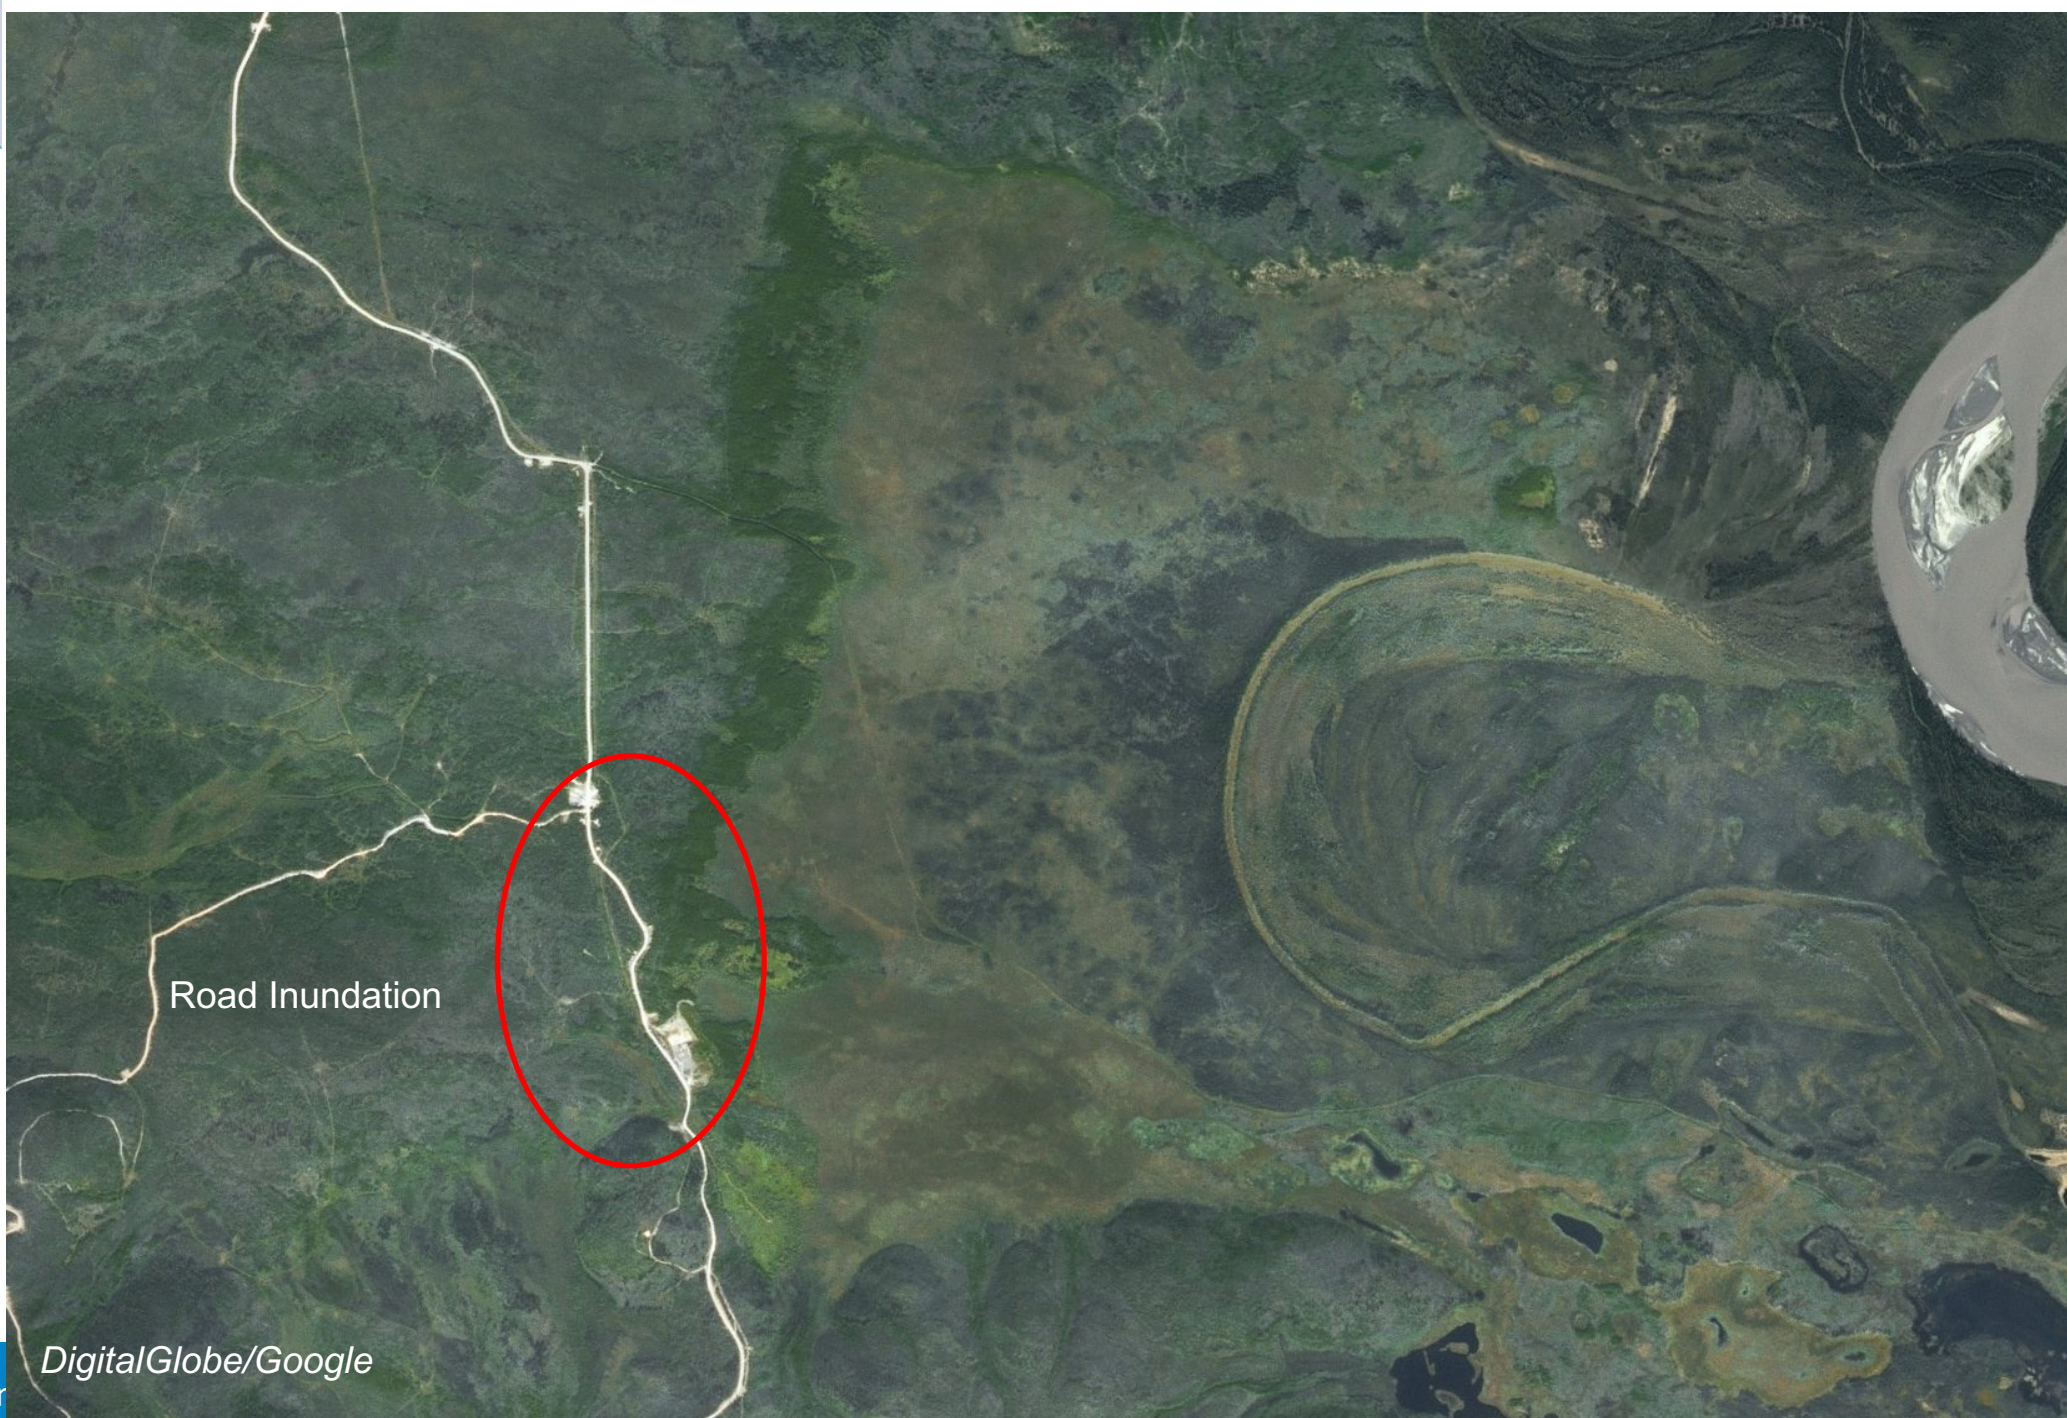
Road Inundation

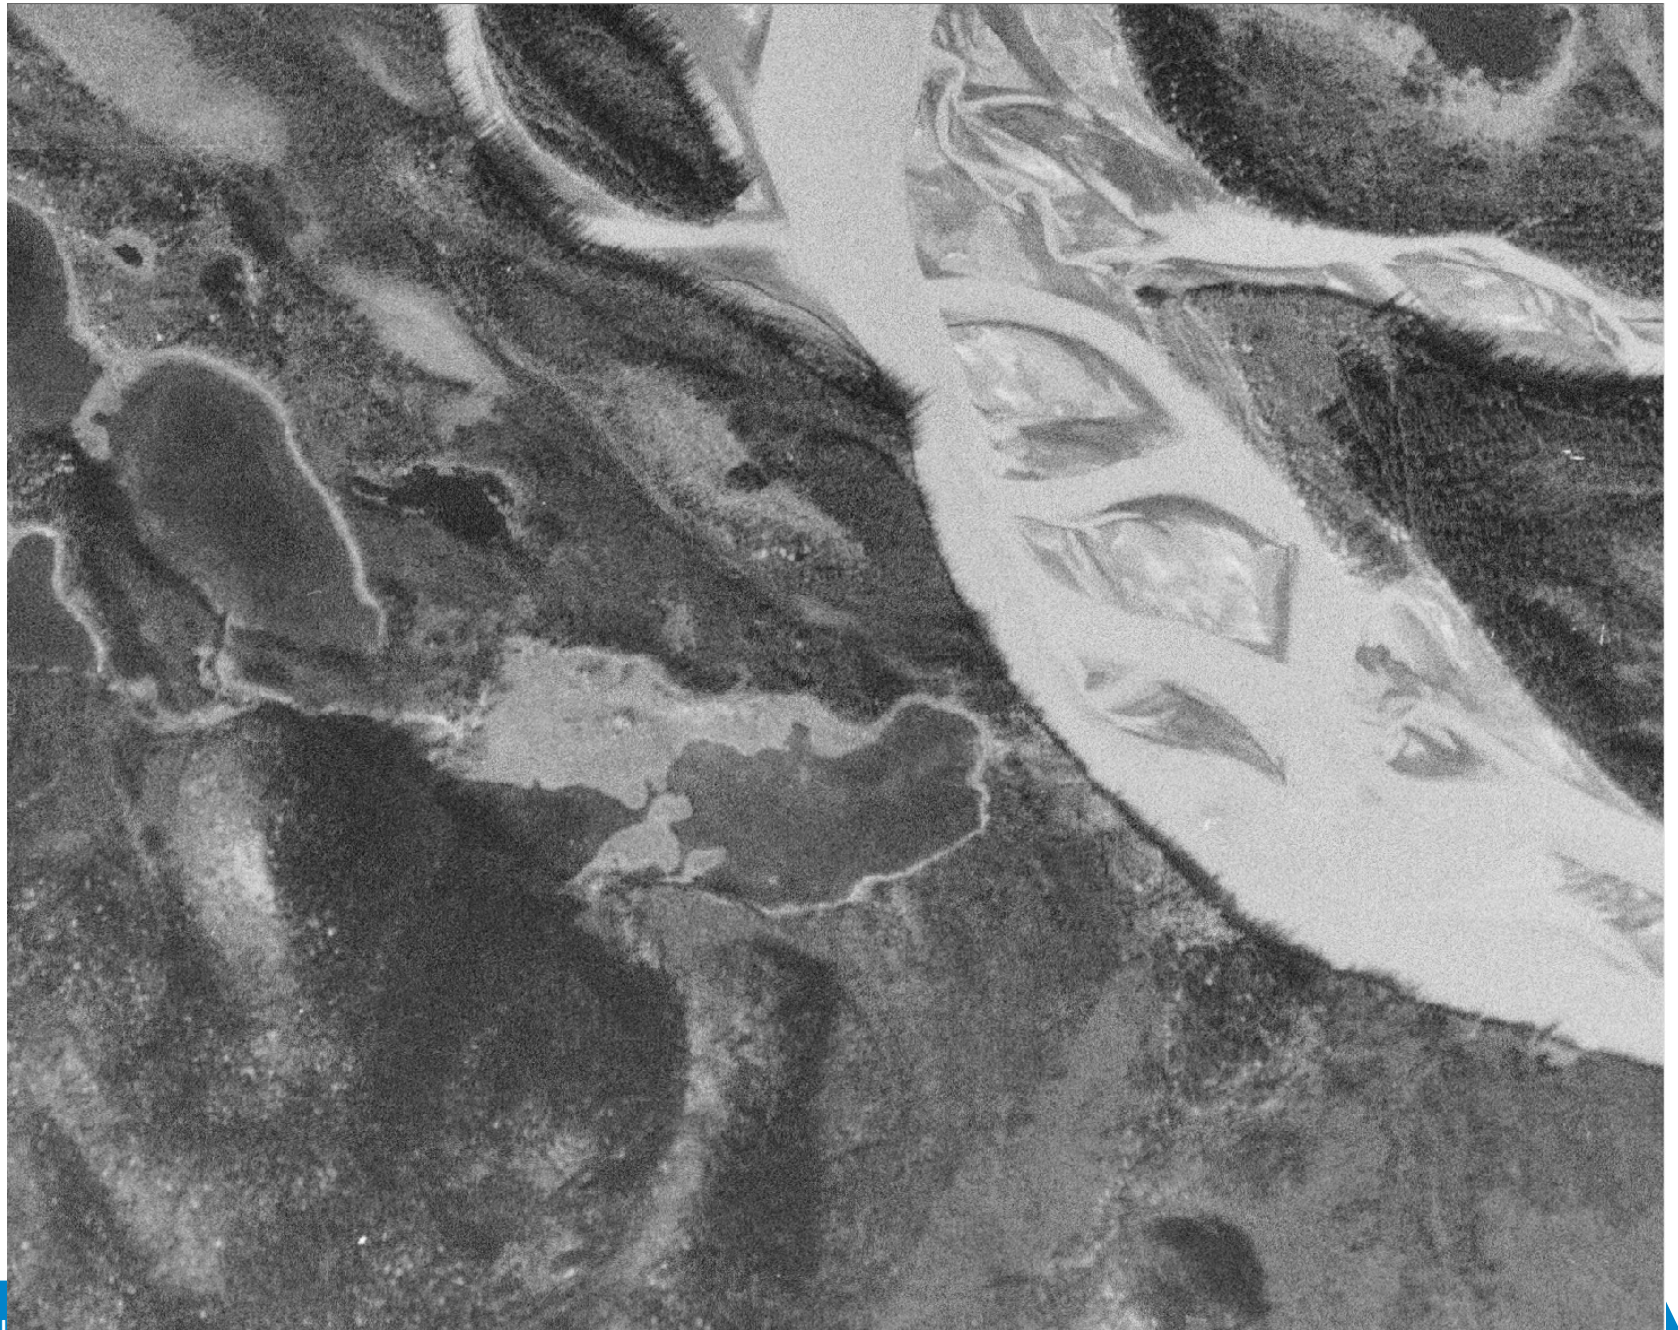
# Tanana Breach in 1948

DOD Aerial Imagery, Sept 14

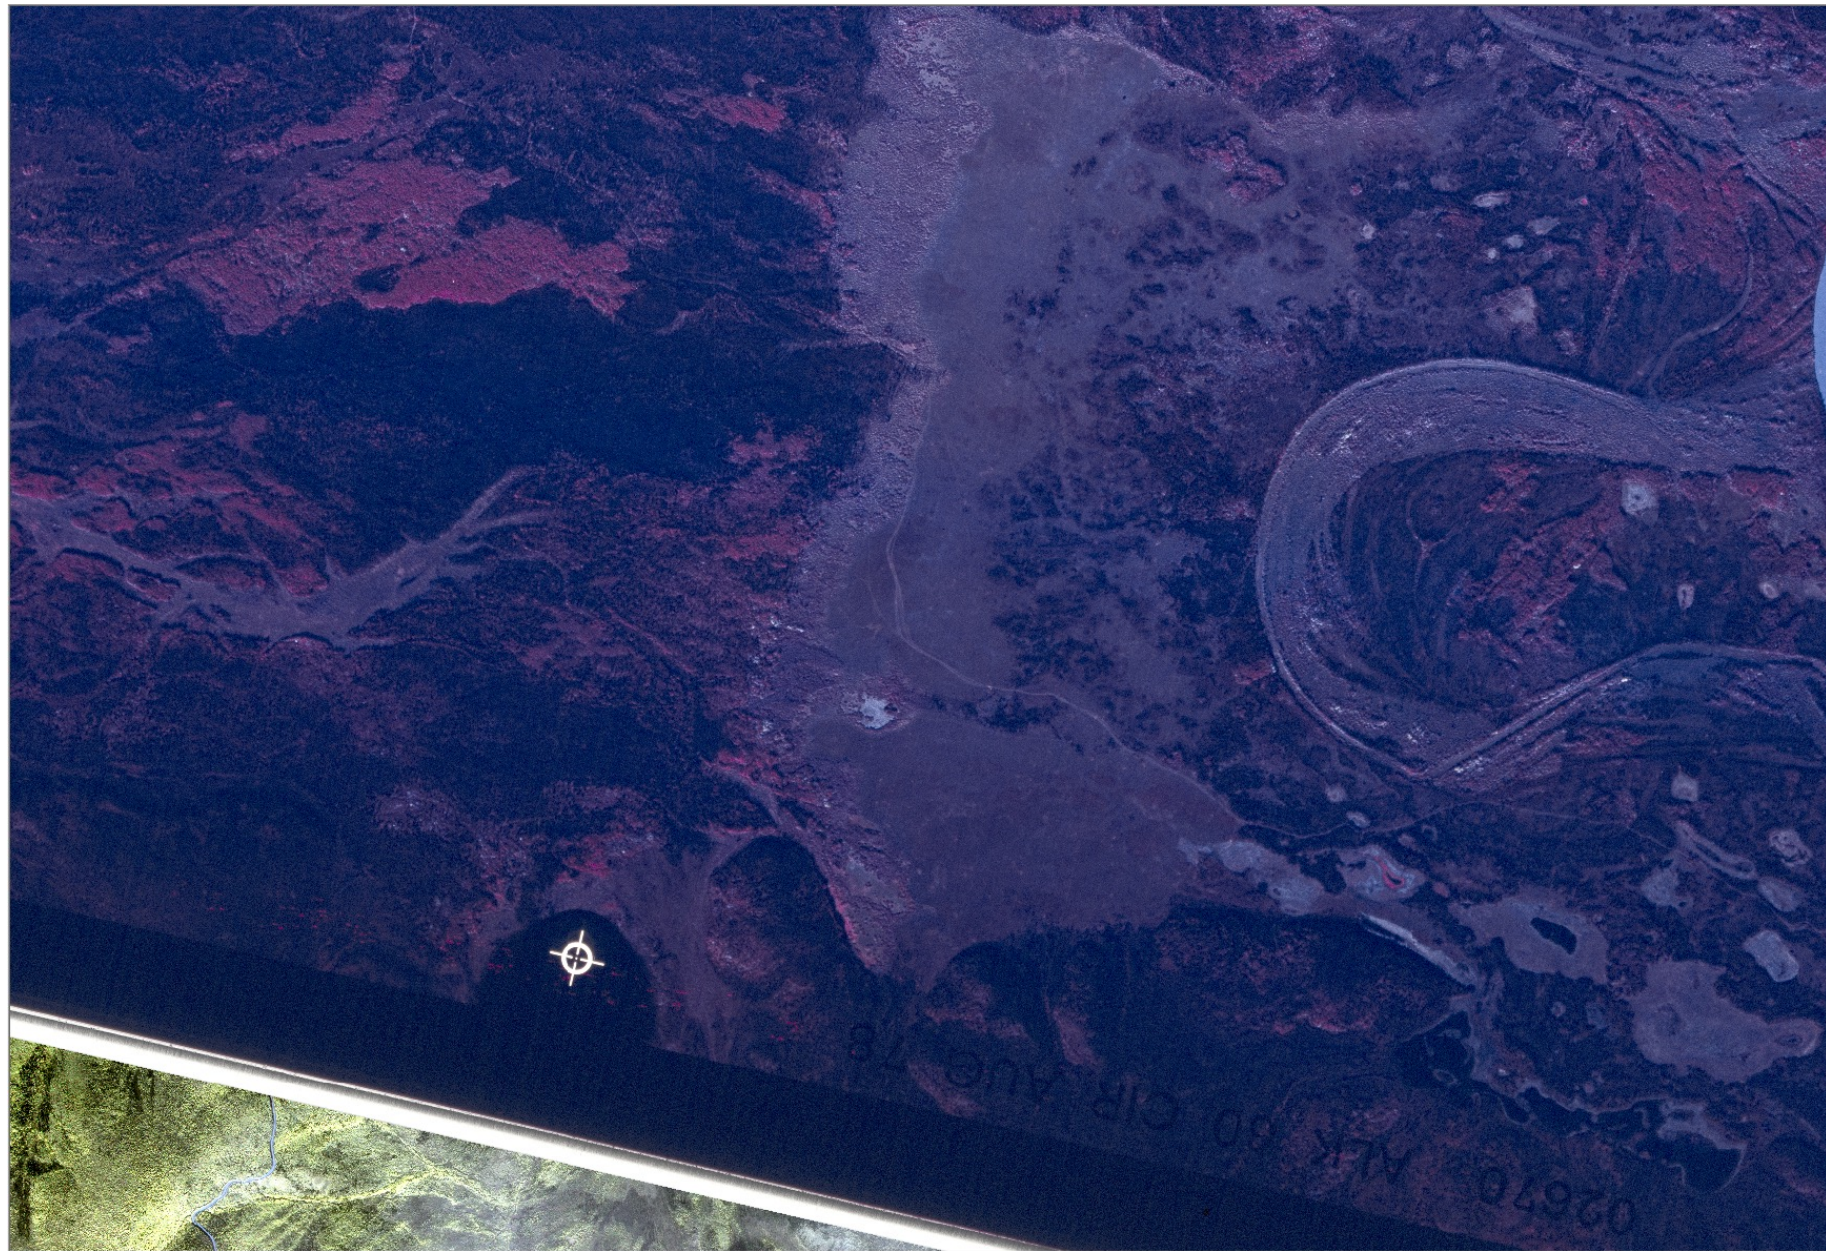
# Flood Plain in 1978

AHAP Imagery, Aug 28

- Vegetation imagery alone suggests there's an ample supply of water at the western edge of the flood plain near the Tetlin/Avalon Road junction. But the 2017 flood blew past this line of vegetation. Causes for ample water along this line could be: a topographic low point with pooling of rainwater, remnant surface water from past flooding, groundwater surfacing and/or a change in soils.

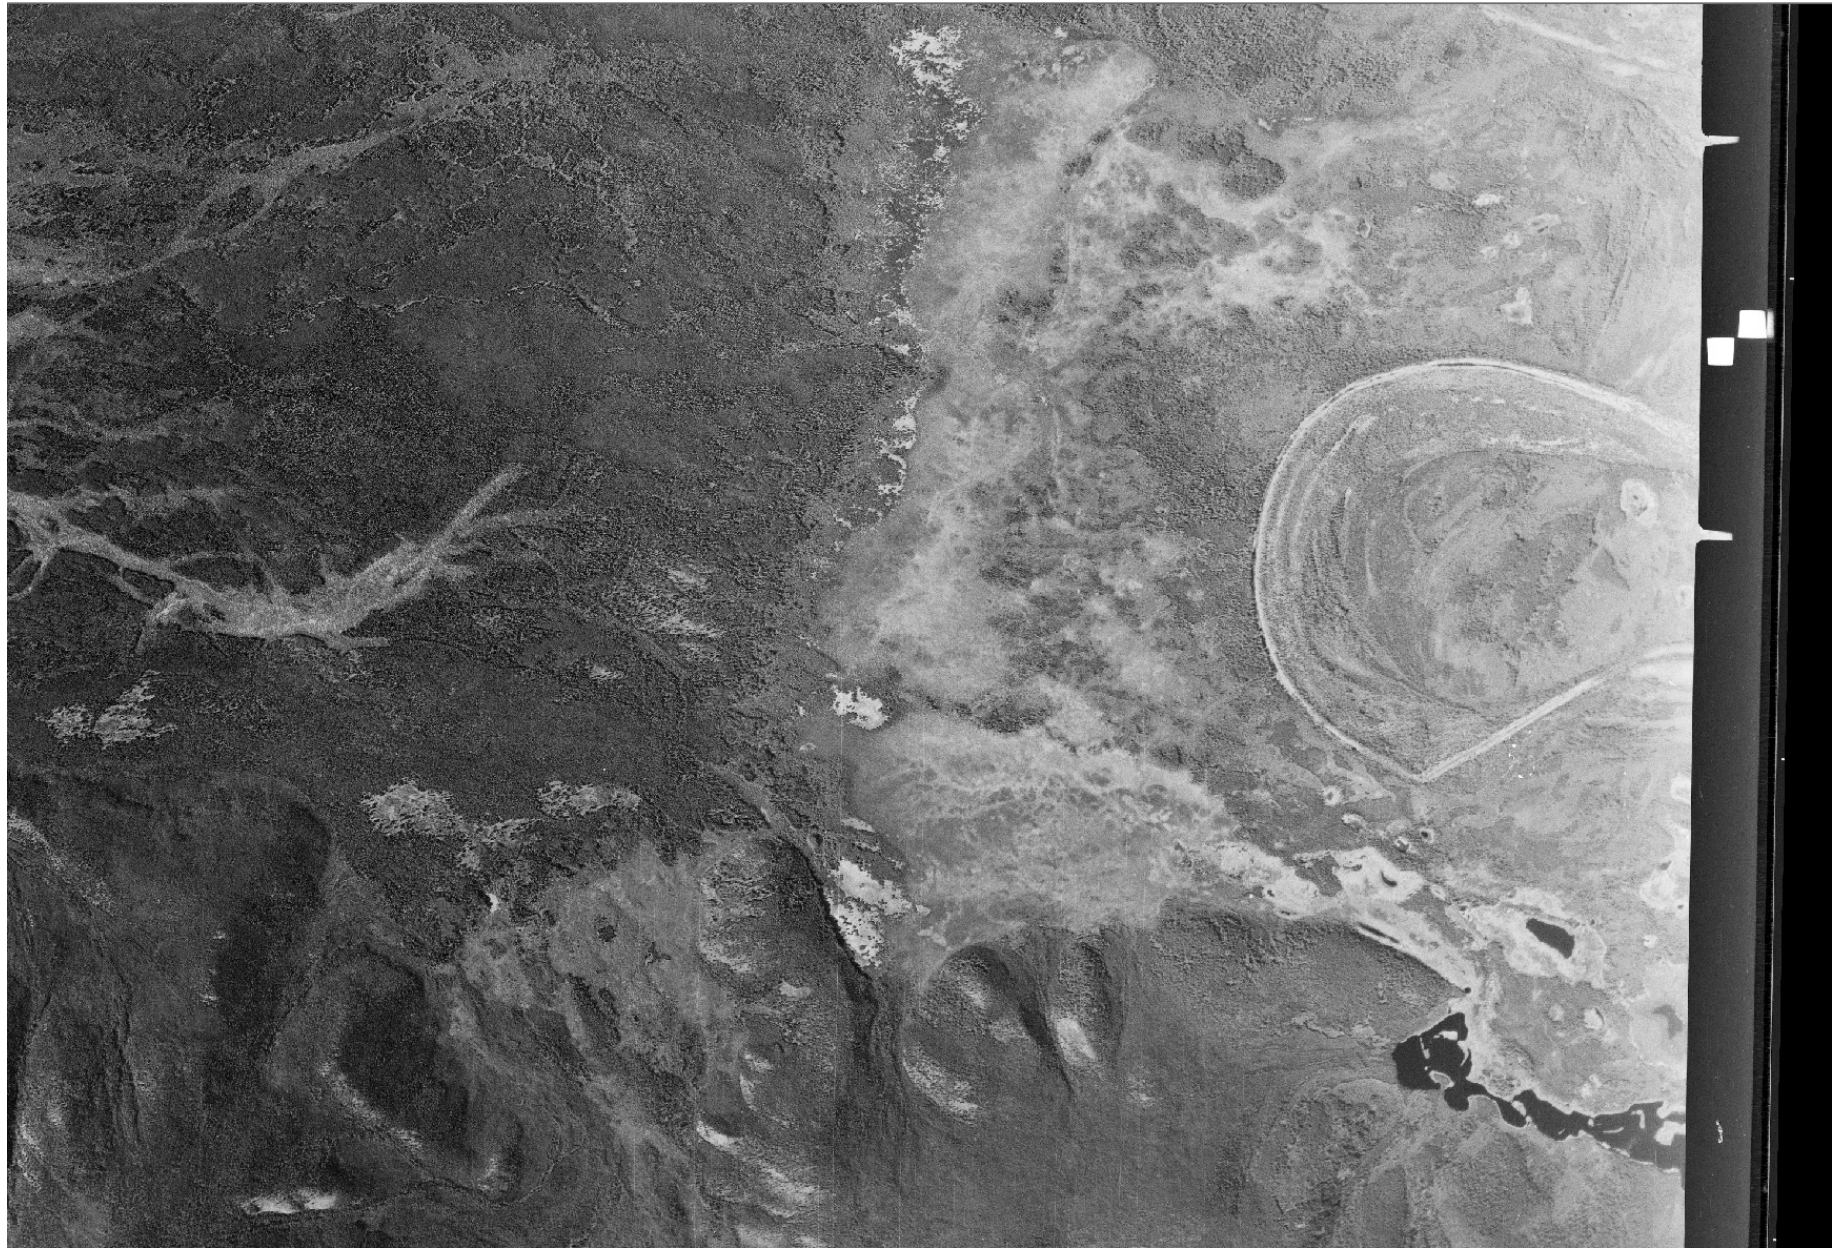
# Flood Plain in 1955

DOD Imagery, Jun 18
